LAND USE HISTORY OF THE GUALALA WATERSHED

BY
DONALD MORSE RPF 2158
CALIFORNIA DEPARTMENT OF FORESTRY AND FIRE PROTECTION

**PREPARED IN COOPERATION WITH THE CALIFORNIA RESOURCES AGENCY'S
NORTH COAST WATERSHED ASSESSMENT PROGRAM**

APPENDIX 3: LAND USE HISTORY OF THE GUALALA WATERSHED

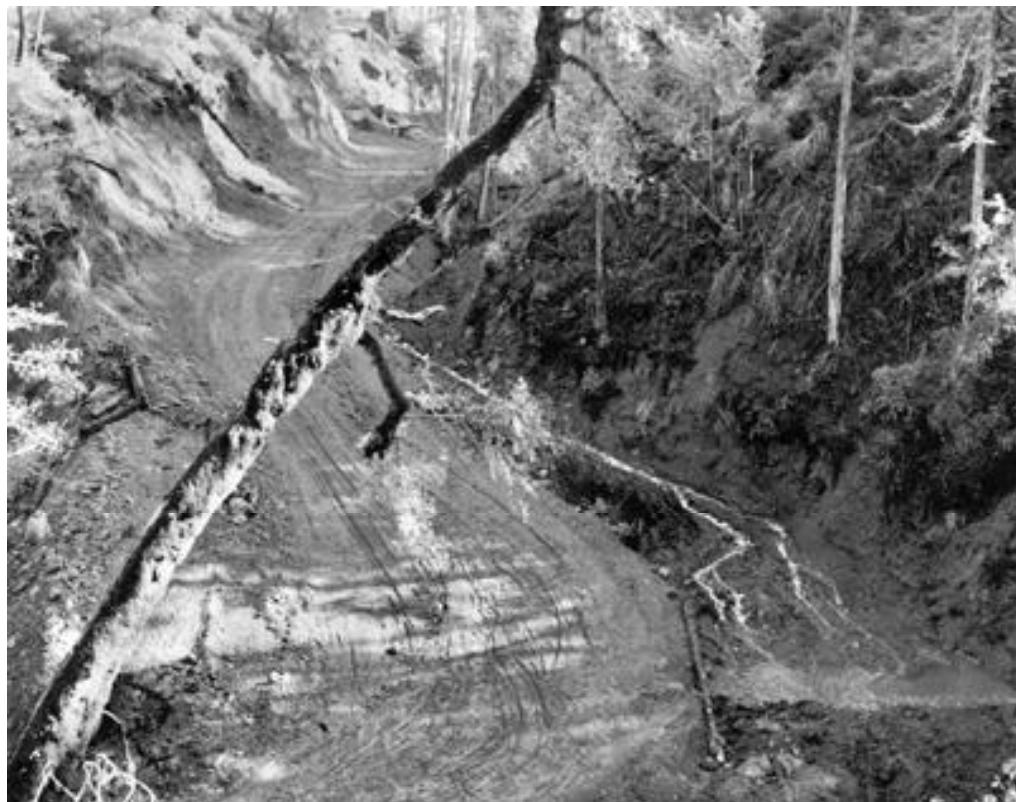
Photo Inset On Title Page: A road following the streambed, November 21, 1955, forcing the creek to flow under the road (center) and then across the road sidecast (right).

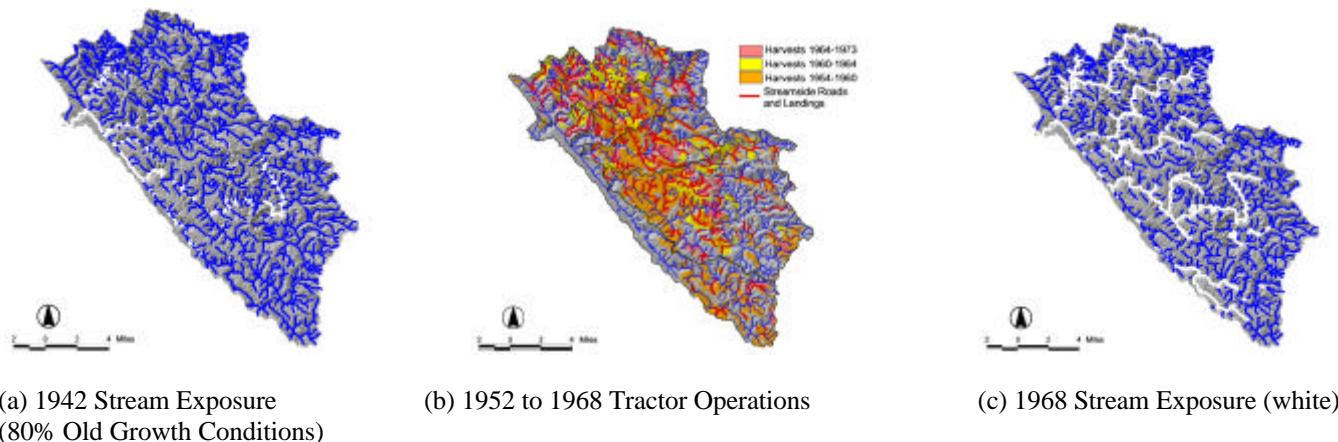
Figure 1: Overstory riparian shade canopy elimination throughout the Gualala Watershed by 1968

In the mixed conifer –oak woodland areas in the north east and east areas of the watershed, a large portion of the original coniferous tract had been harvested by 1968. These had occupied north slopes and riparian areas on private ranch parcels. Prolonged cattle grazing in these areas after harvest prevented timely reestablishment of canopy cover over fish bearing watercourses. This presumably elevated stream temperatures.

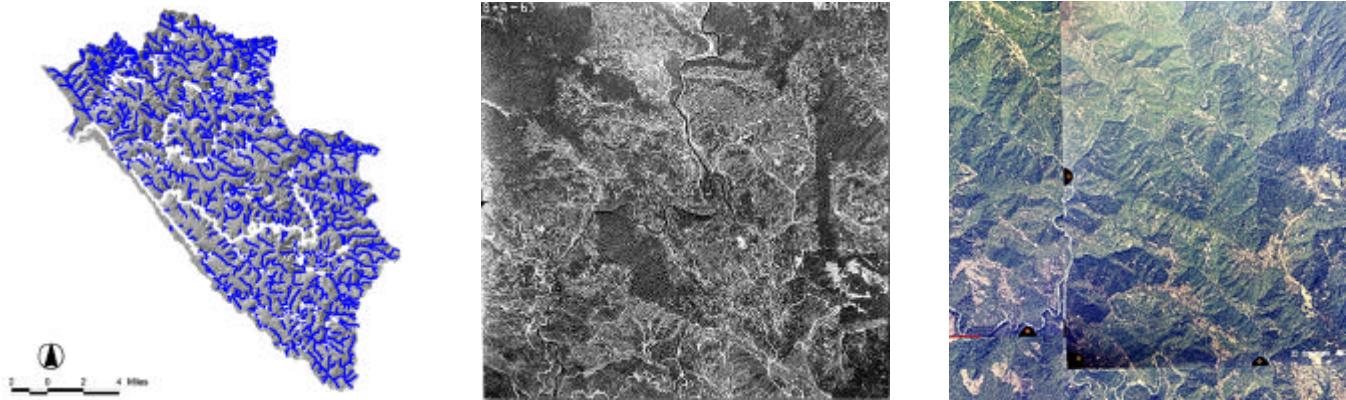
Figure 2: (a) 1999/ 2000 stream exposure (white) (b) Central Rockpile Subbasin 1963 (c) Central Rockpile Subbasin 1999

As of 2001, canopy cover measurements taken during habitat typing surveys show improving canopy closure, reflecting riparian vegetative in-growth since 1968, and infrequent timber harvesting until the late 1980s. Aerial photos from 1999 substantiate these findings, with bank exposure reduced to approximately 25% averaged throughout the watershed (Figure 2, below). Streamside canopy now consist primarily of 40 year old pole to mid sized sized conifers/ mixed conifer hardwood stands in the middle to upper basin reaches. This represents an overall gradual improvement in stream cover from 1968 conditions when anadromous bearing streams were entirely exposed without cover. There has been active timber harvesting in the 1990s throughout the lower sub-basin reaches. However, the requirement of minimal entry WLPZ corridors over streams appears to have provided adequate mitigation. In addition, riparian corridor widths and leave tree density standards have been gradually expanded since 1995. These corridors are now managed as minimal to no entry zones as future late seral habitat areas. Despite these trends, contemporary stream surveys now generally show predominantly young of the year steelhead and absence of coho.

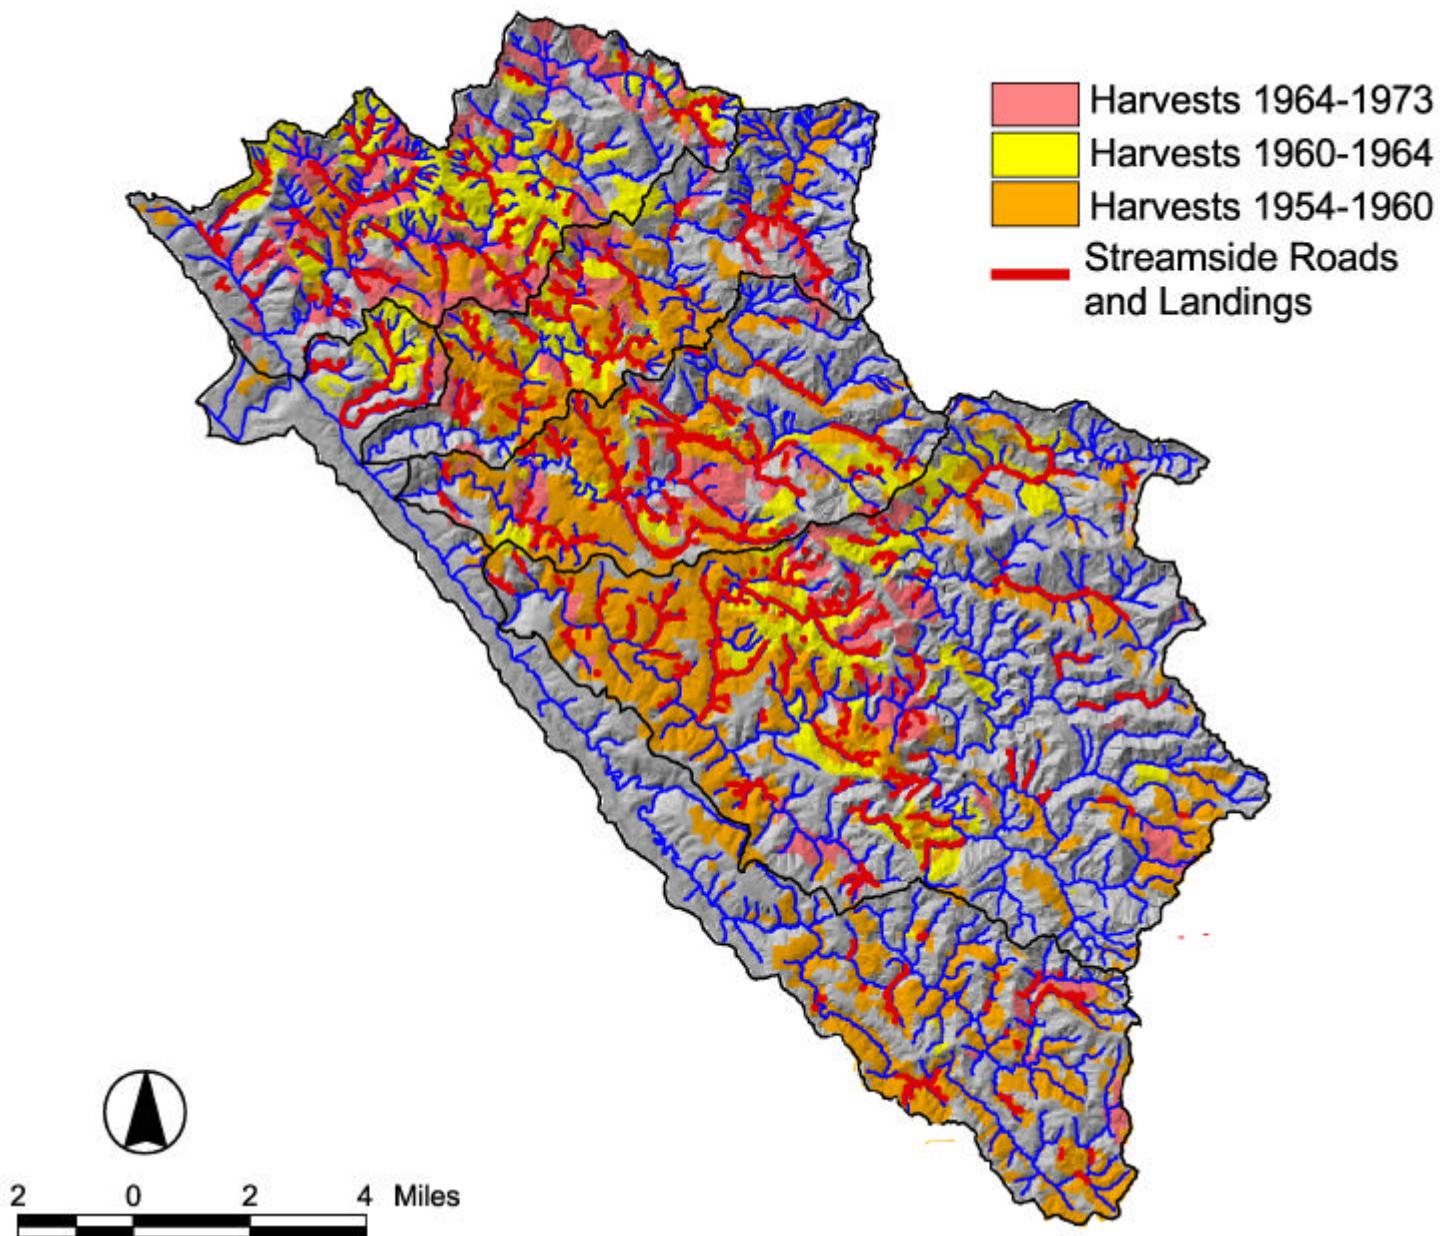
Figure 5: Streamside Roads and Landings 1968. Red lines show where the road or landing (circles) are built either in or immediately adjacent to the stream channel. Road fill has been pushed over the streambank into the watercourse at these locations.

Modern roads cross streams at a perpendicular rather than following the stream to one side. This makes modern road sediment inputs more related to the immediate road watercourse crossing sites and road approaches to streams. Historic roads following the creek are prone to failure where streambanks underlaying the road collapse during storms as a function of fluvial velocity, steepness, and geologic instabilities (see Figure 5).

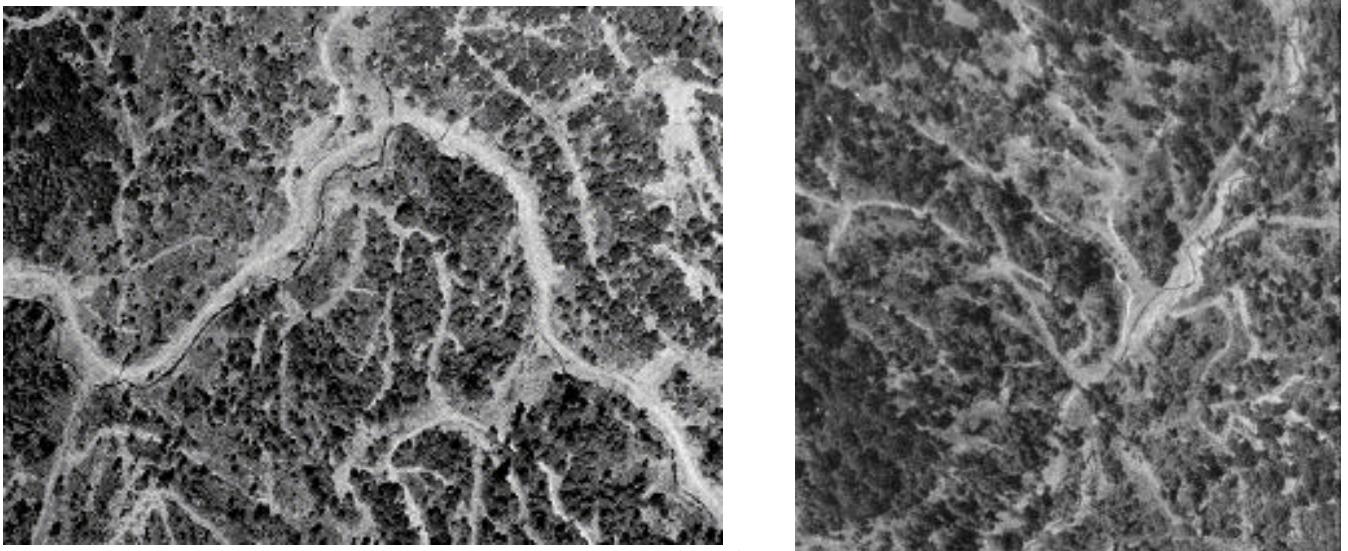
Figure 6: Streamside roads in the North Fork Fuller Creek ravine (left) , and in stream roads in an unnamed tributary to the lower Wheatfield Fork basin at Annapolis Fire station (right), 1965.

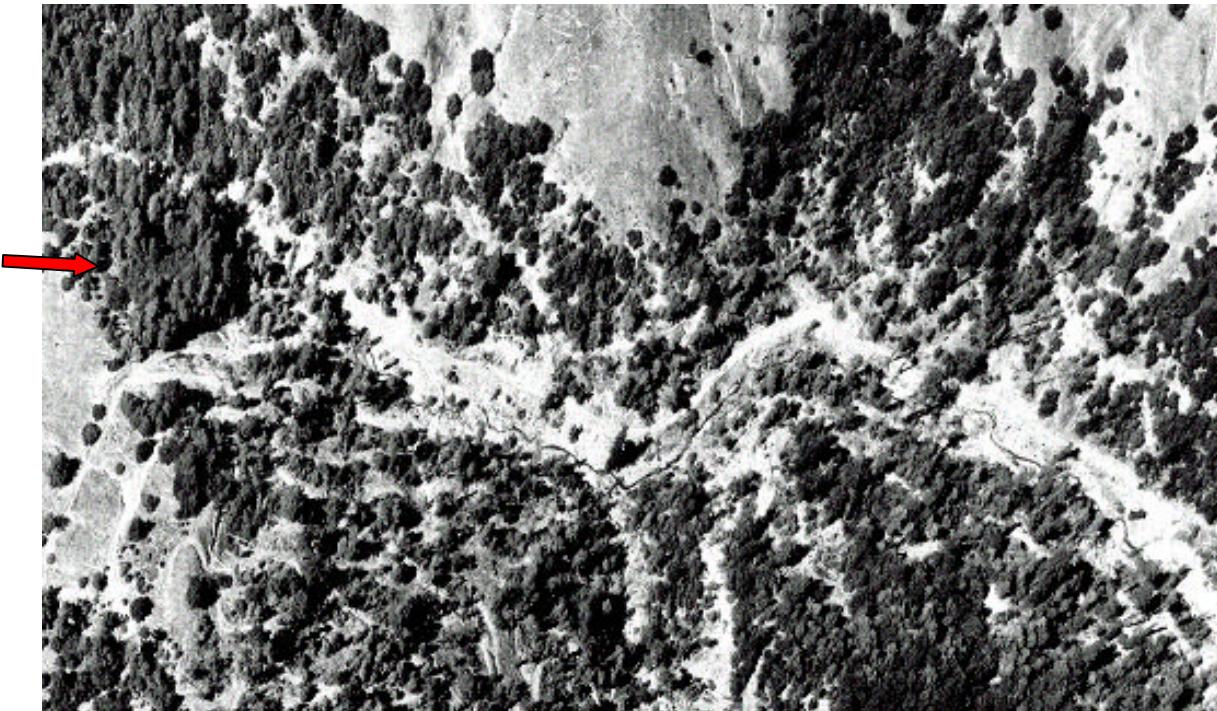
Figure 7: Streamside road along Elk Creek, 1965, Wheatfield Fork. Initial Right Of Way (ROW) clearance is complete along the road and riparian area, and logging operations are active to clear downslope coniferous stands (red arrow).

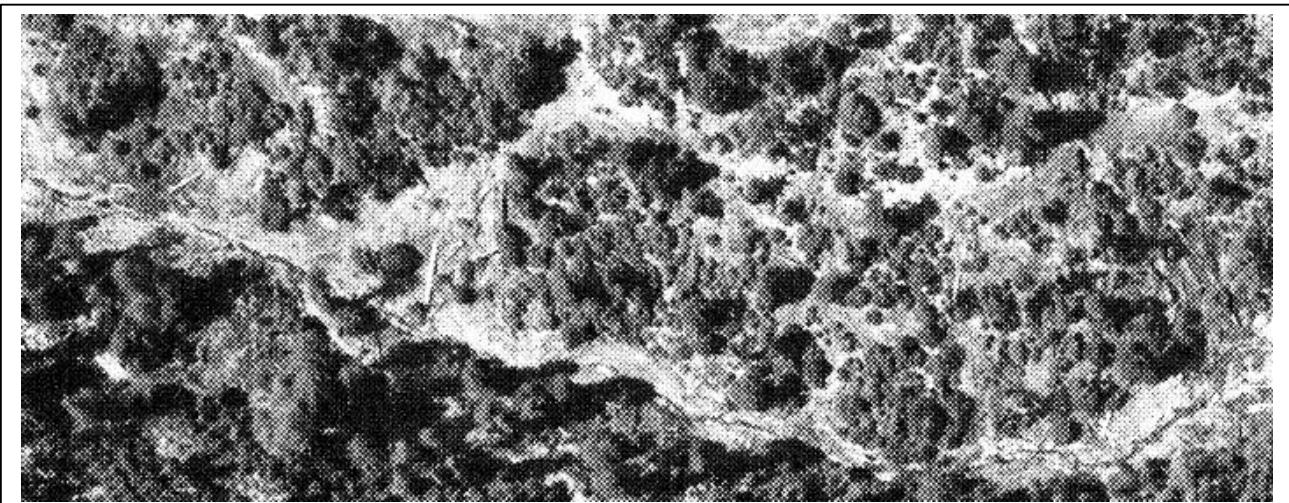
Figure 8: The in stream road in a tributary stream to Grasshopper Creek eliminated natural channel structure. The 1964 storms washed soil debris onto the stream channel already impacted by the in stream road construction. This caused the stream channel to meander through the logging debris, finding a new course (1965).

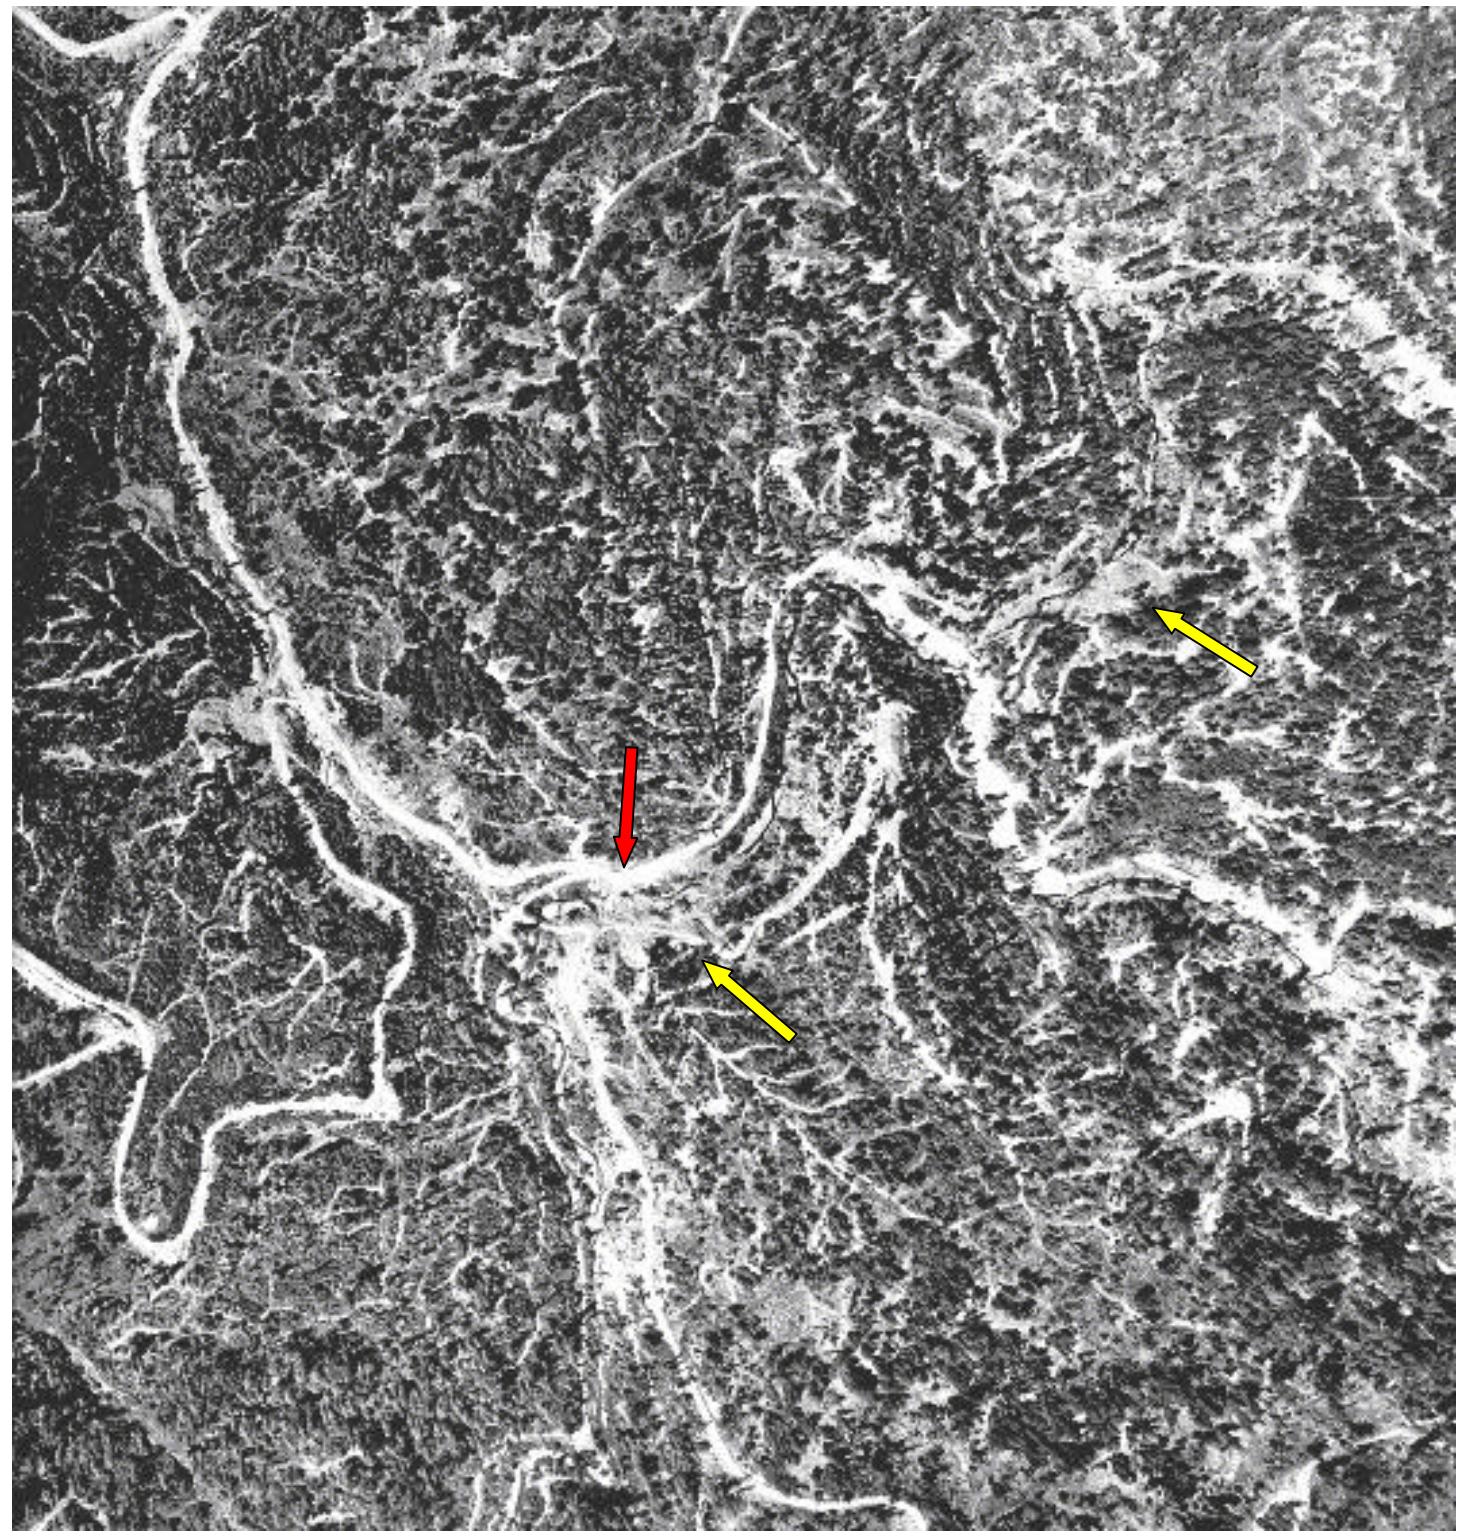
Figure 9: Central Landing Complex Built Over The Main Stem Fuller Creek, and Streamside Roads, June, 1965. High storm flows during the 1964 flood event incised the landing complex (lower left, yellow arrow) and undercut the lower North Fork Fuller Creek road (upper right, yellow arrow), collapsing a one quarter section of the road into the creek.. Note meandering stream flow patterns over filled channel substrate (red arrow) By 1984, most of this debris had washed downstream, and Fuller Creek flowed straight through the original V-shaped stream channel bordering the landing. The 1996 storms washed remaining debris out to expose the graveled substrate seen today

In addition, new streamside roads pushed fresh road fill towards the creek over the streambank. This sidecast is especially prone to failure during high flows. Historic road related debris slide failures accessing streams have been identified as a major source of land use induced sediment sources. Major storm events can trigger multiple road debris slide failures accessing streams (Figures 9, 14, 17, and 20).

The 1965 photos show that most of the point source sediment discharges consist of road debris slides accessing streams activated during large storm events. Figures 9, 14, and 20 show multiple road debris slides accessing watercourse over relatively short sections of the stream. Fresh debris slides fanned out over the channel, forcing the stream to meander around the slide mass. These meandering stream channel patterns in Fuller Creek returned to a more lineal pattern in observed in mid 1984 photos, and again with 1999 photos (see Figure 39, below). Meandering channel patterns in Sullivan and Grasshopper Creeks also returned to a more lineal pattern thru 1984 and more so by 1999. In Fuller and Sullivan Creeks, a graveled stream substrate can be found today in contrast with a silt and sand dominated substrate indicated in the 1965 photos. The Fuller Creek basin has been particularly targeted by the Gualala River Restoration Council for rehabilitation work. Stabilizing sediment sources has apparently allowed residual in-stream sediment loads to be washed downstream, reexposing the graveled substrate seen today. 1965 air photo coverage is only available in the east portion of the watershed.

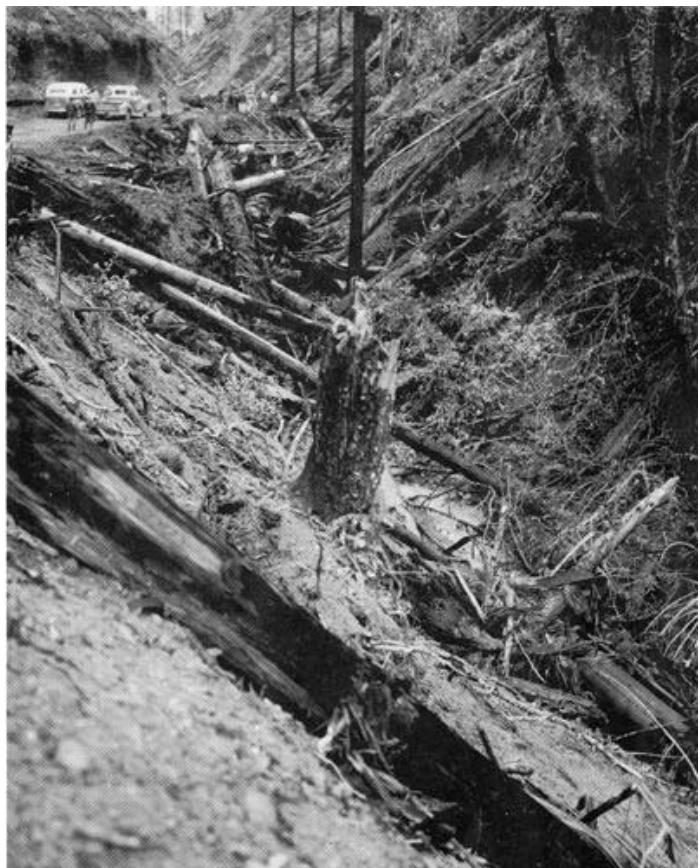
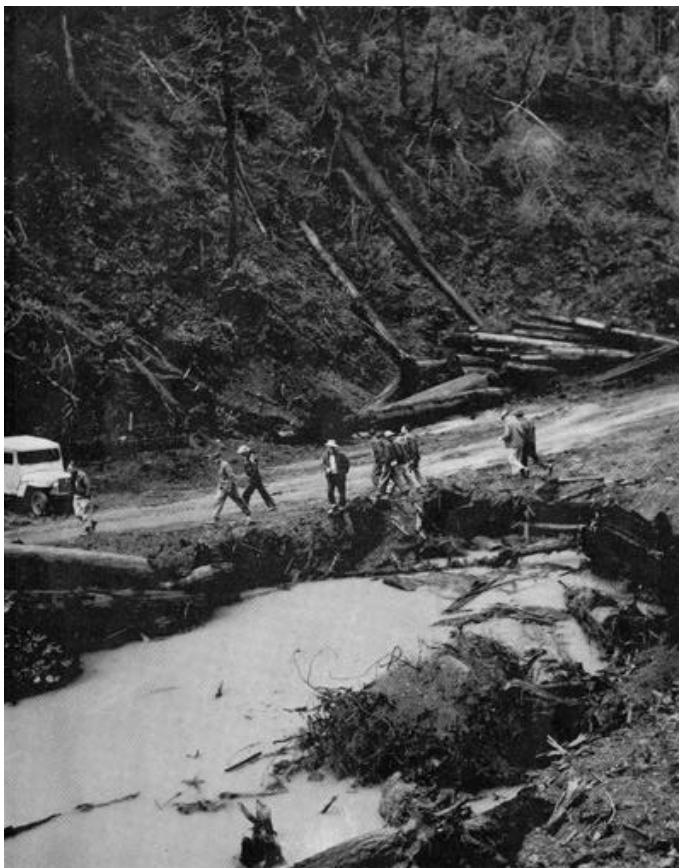
Figure 10: Left: Logging debris sidecast from the main streamside road in Grasshopper Creek, left, November 21, 1955. This road is now abandoned and vegetated.

Right: A primitive log chunk road crossing in Grasshopper Creek, right, November 21, 1955. The stream flows through the logs and debris pushed into Grasshopper Creek to make the road bed. These substandard road crossings generally failed during large storm events (lower right).

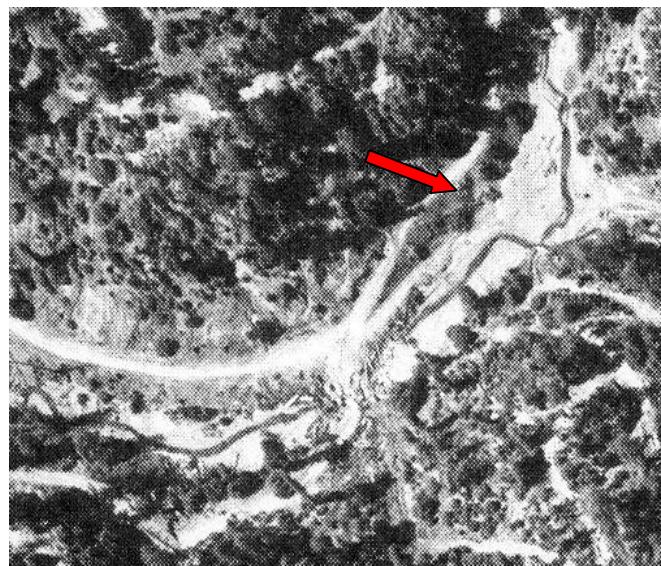
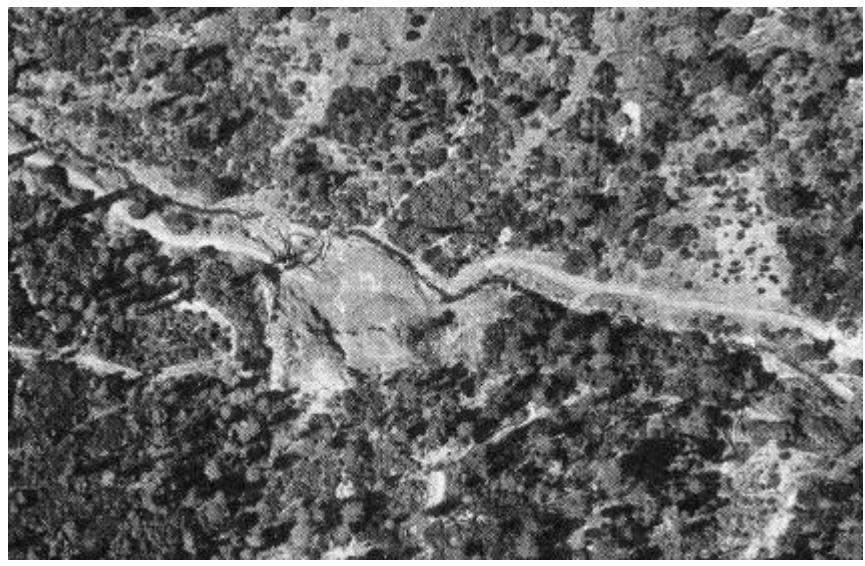
Figure 11: Left: Log debris blocked the inlet of a primitive log dirt crossing of Grasshopper Creek (left) from the 1964 flood, causing the creek to divert onto the south road approach, then route back to the main channel through a debris slide. The abrupt turn in the creek (red arrow) follows a long term geologic terrace per 1942 photos.

Right: One half mile downstream, Grasshopper Creek washed out a primitive log debris road crossing (June, 1965).

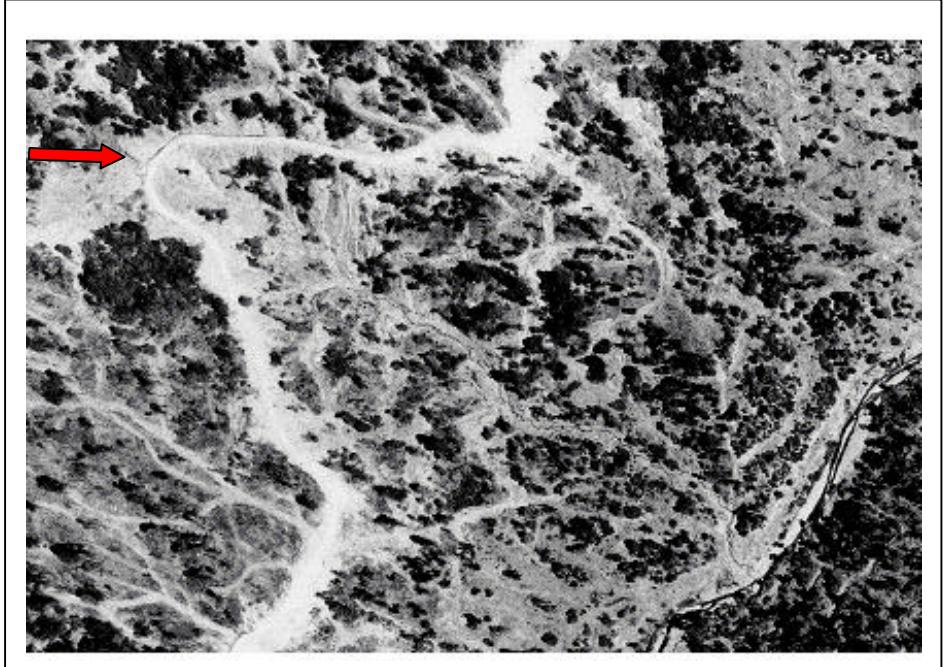
Figure 12: Watercourse diversion down the main road (left) discharged down several skid trails to the lower in stream road. This is a tributary creek to the North Fork Wheatfield, June, 1965.

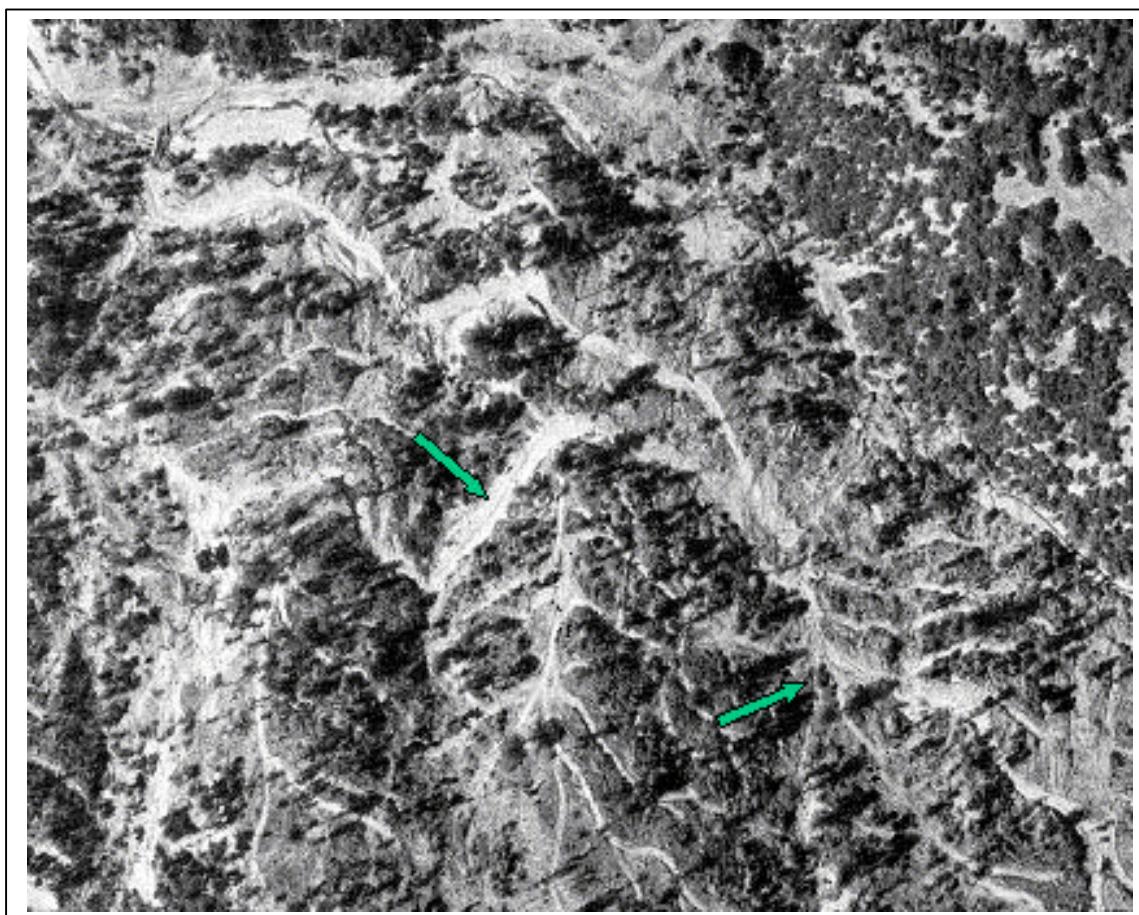
Figure 13: Road and skid trail terraced network on steep north facing sideslopes in Wolfe Creek, east Wheatfield basin. Green arrows show gullying down the roads.

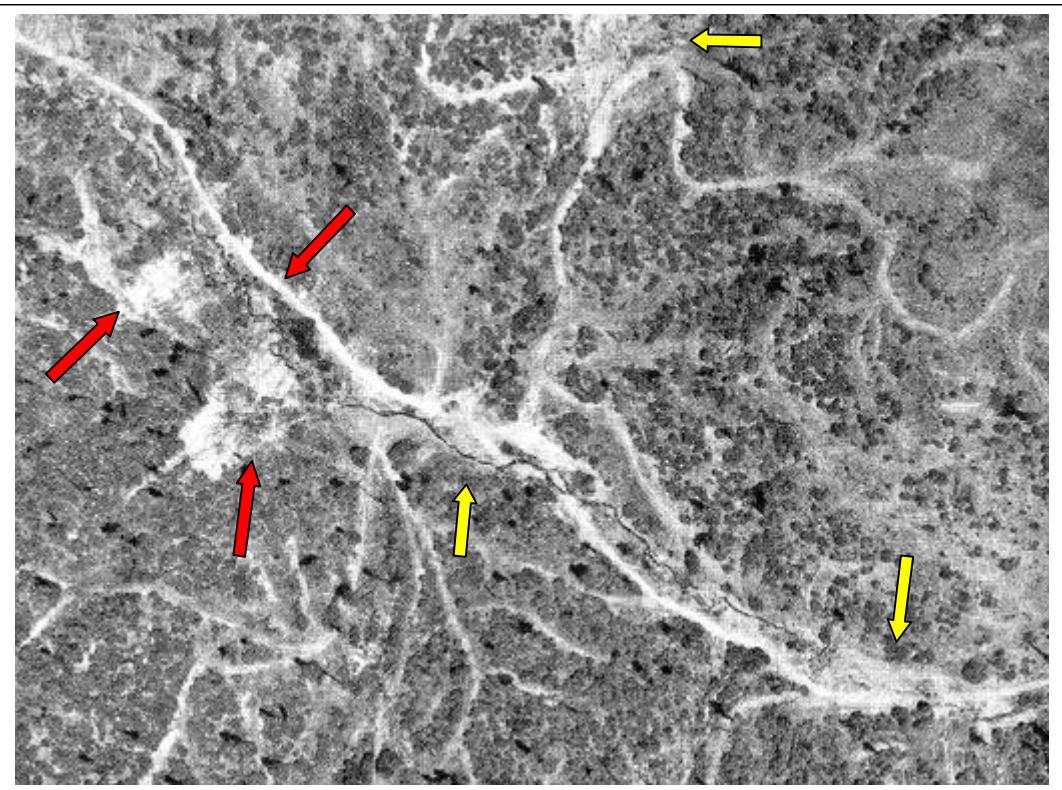
Figure 14: Multiple road debris slides accessing Tobacco Creek (red arrows). Three instream landings (yellow arrows) consist of wood chunks pushed into the stream channel and topped over with dirt fill. These are located at the confluence of several streams. The left landing (center) and top landing have incised down while the right landing shows overflow patterns.

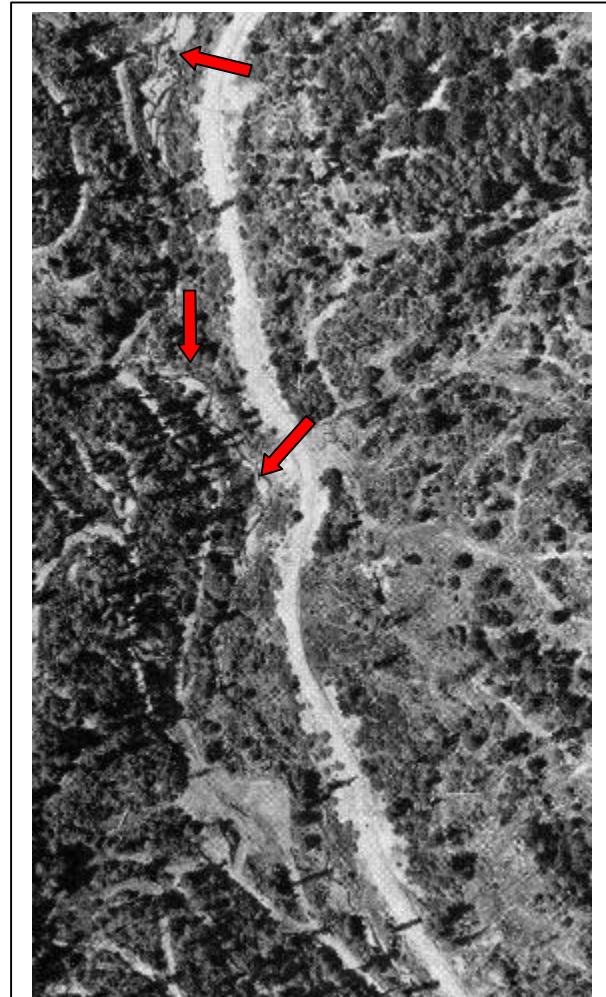
Figure 16: Braided channel patterns and sediment step fans, Fuller Creek

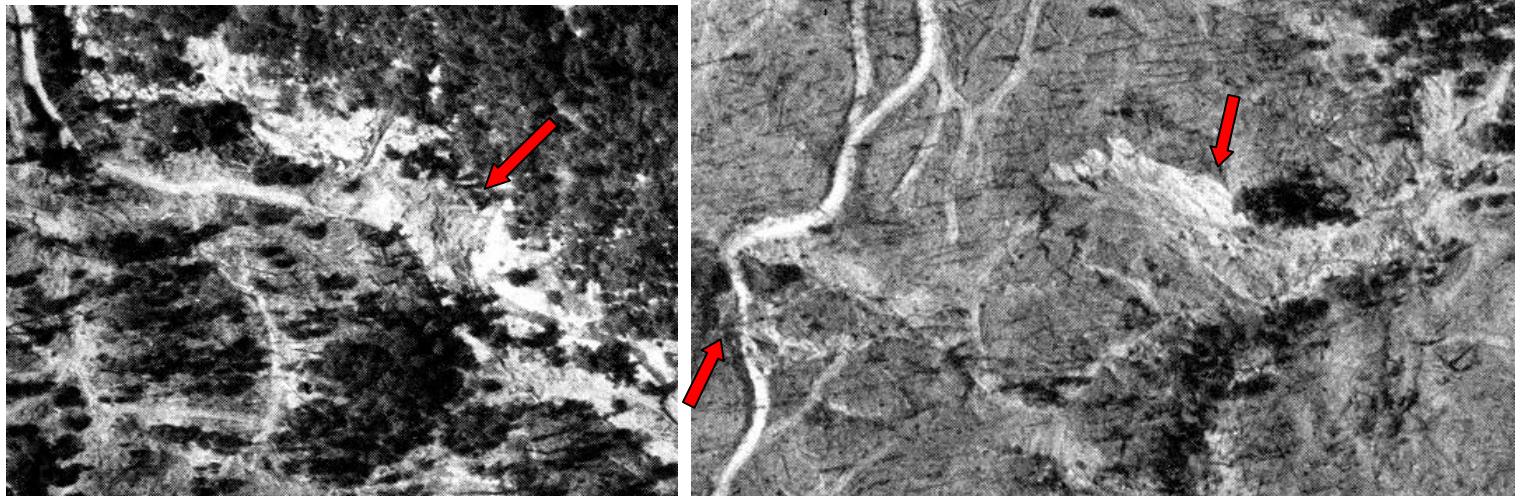
Figure 17: Left: The 1964 flood event undermined the streamside road, causing a massive debris slide into Wolfe Creek. Note meandering angular channel patterns through the slide debris (red arrow) 1965. Right: Debris slides and debris flows in an operations area in the Danfield Creek tributary subbasin

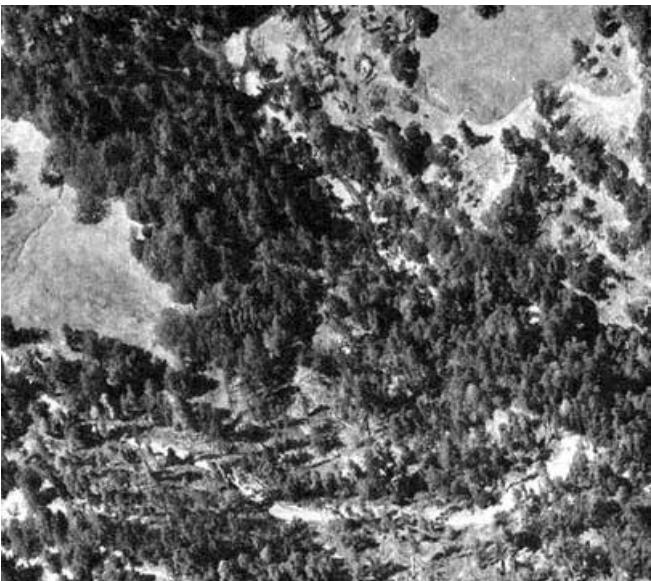
Figure 19: Left: Original old growth coniferous stream cover over upper Rockpile Creek during initial logging Right: Road washouts along a ranch road in the Upper Rockpile PWS, ~300 ft. upslope of Rockpile Creek, 1965.

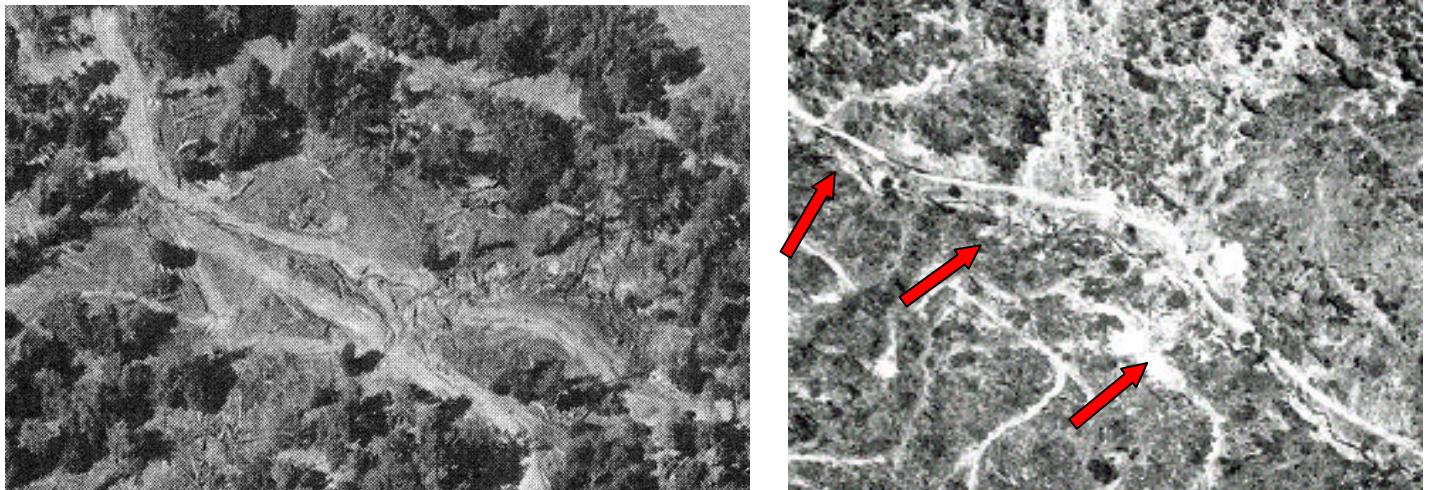
Figure 20: Left: Stream diversion onto a ranch road in the Upper Rockpile PWS, 1965. Rockpile Creek is ~500 feet north. Right: Multiple road debris slides accessing Tobacco Creek.

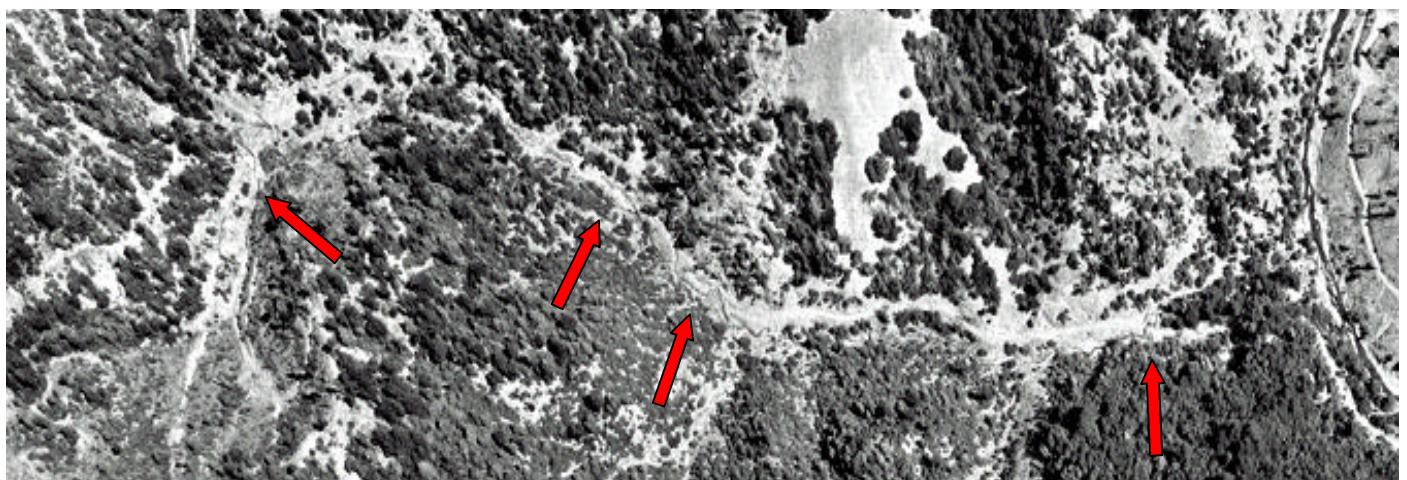
Figure 21: Stream diversions and washouts of a streamside road following a tributary stream to lower House Creek, 1965.

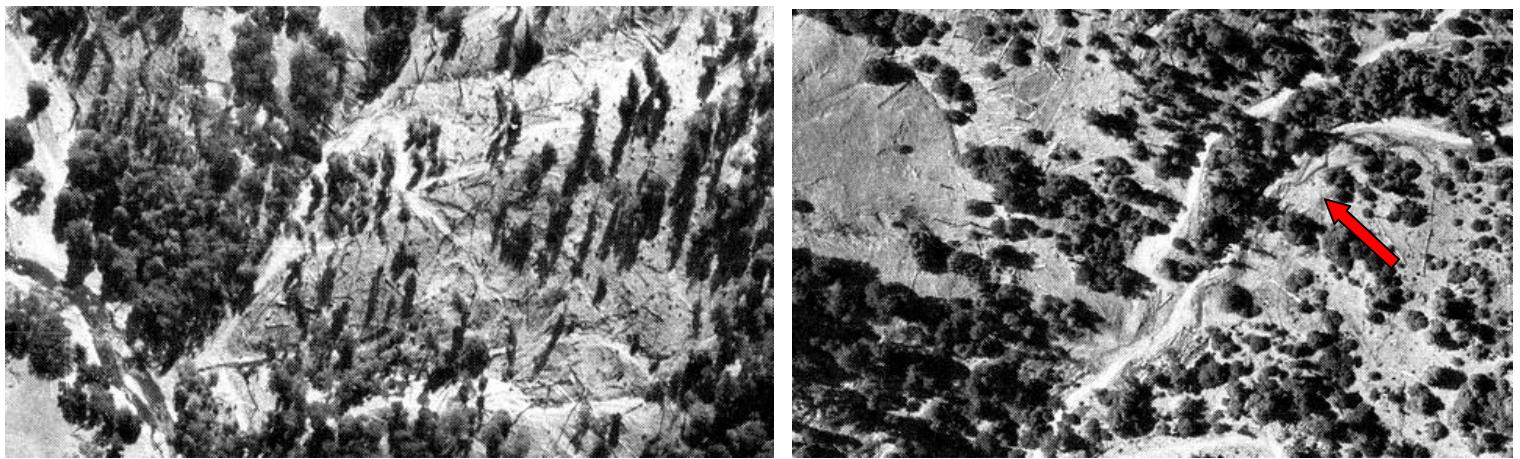
Figure 23: Left: Streamside road along an unnamed tributary to the main stem Wheatfield Fork Right: Road washout slightly upstream.

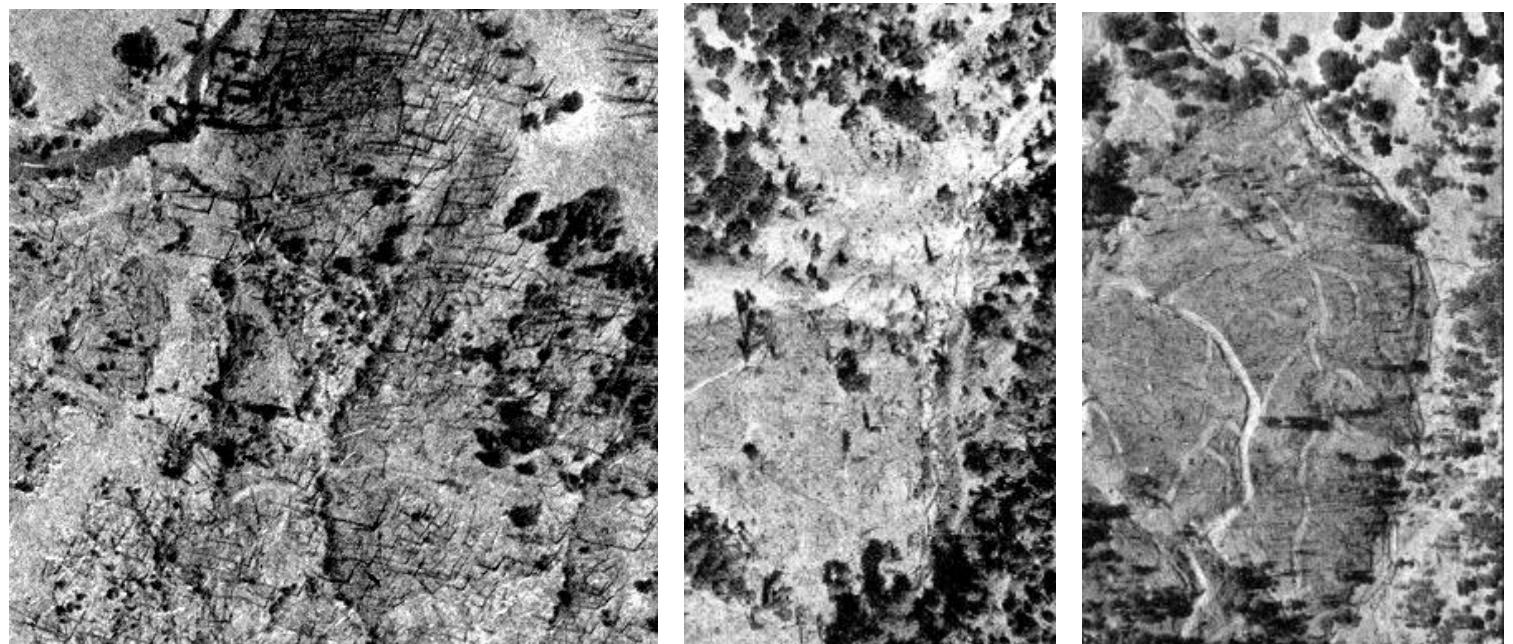
Figure 24: Riparian canopy removal and streamside road networks along the North Fork McKenzie Creek (center) and in the Danfield Creek tributary subbasin (left and right)

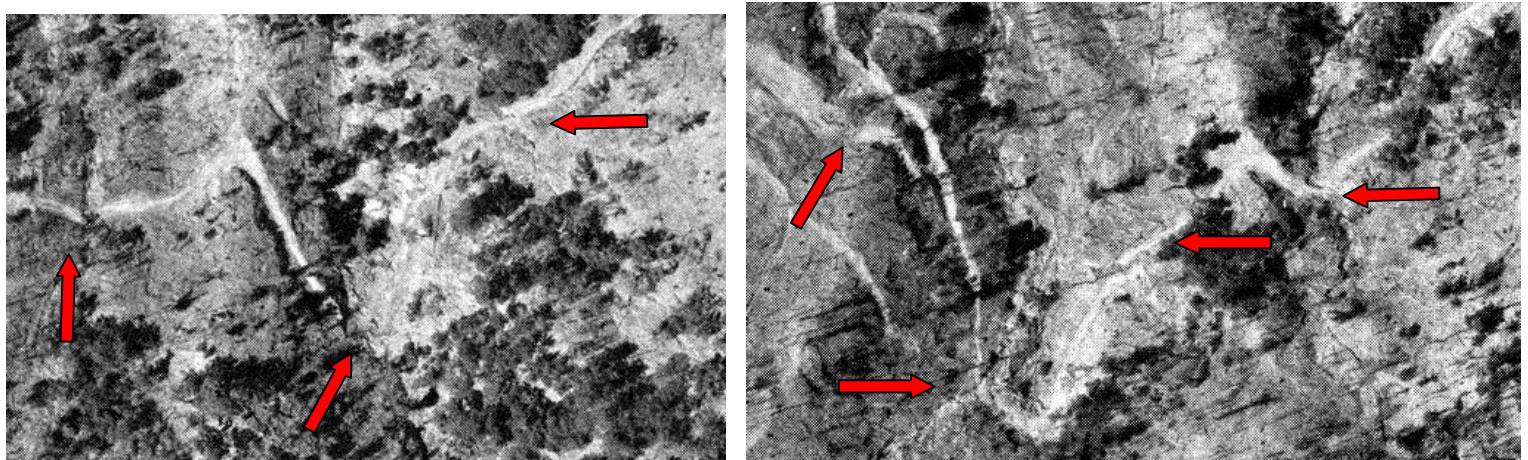
Figure 25: Road debris slides and road crossing failures in the Danfield Creek tributary subbasin. Most of the road crossings in this area show signs of failure.

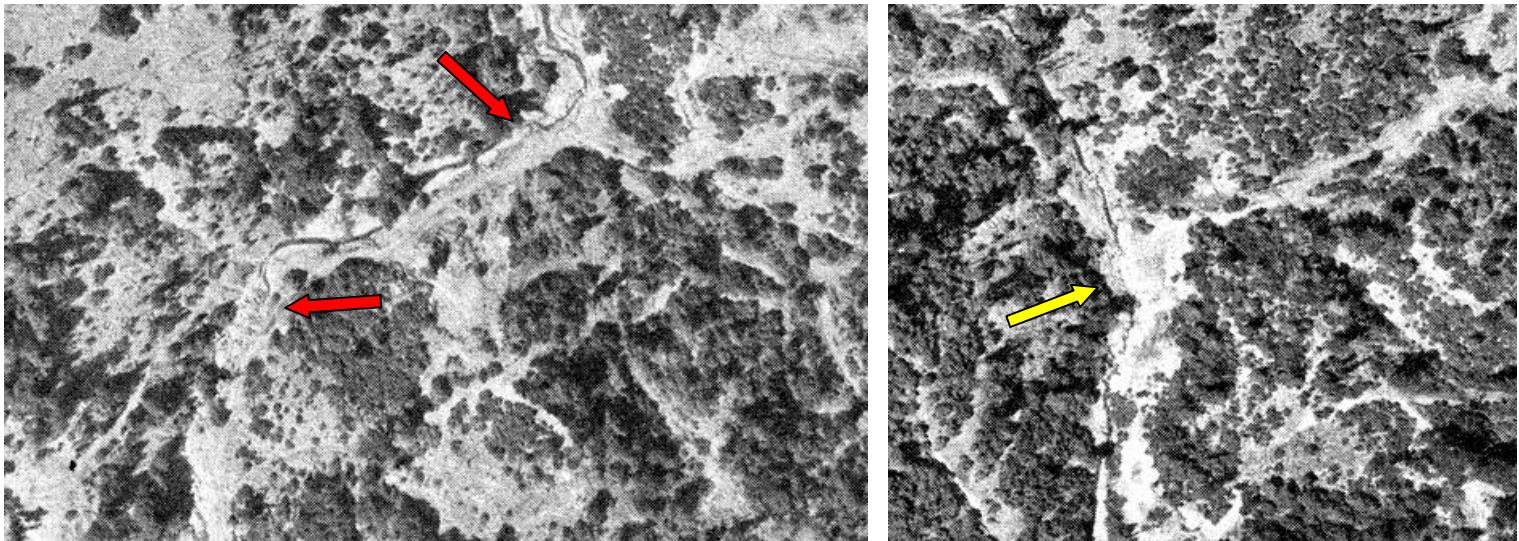
Figure 26: In inner gorge canyons, road building was often confined to the streambed by the steep inner canyon walls. Tractors graded the channel zone flat to one side, often burying the watercourse with fill sidecast. This forced the stream to meander through the road fill, finding a new course offset from the original channel. The 1965 photos show a disrupted channel pattern in these areas, characterized by frequent channel braiding, (red arrows) and abrupt turns in the channel (yellow arrows). Upstream of the disturbance, the channel typically shows a well defined central channel. Turns in the channel are comparatively gradual. In disrupted channel areas, the channel narrows down as the stream spreads through the debris and disturbed ground in angular, dissected patterns (Upper South Fork, top left and right).

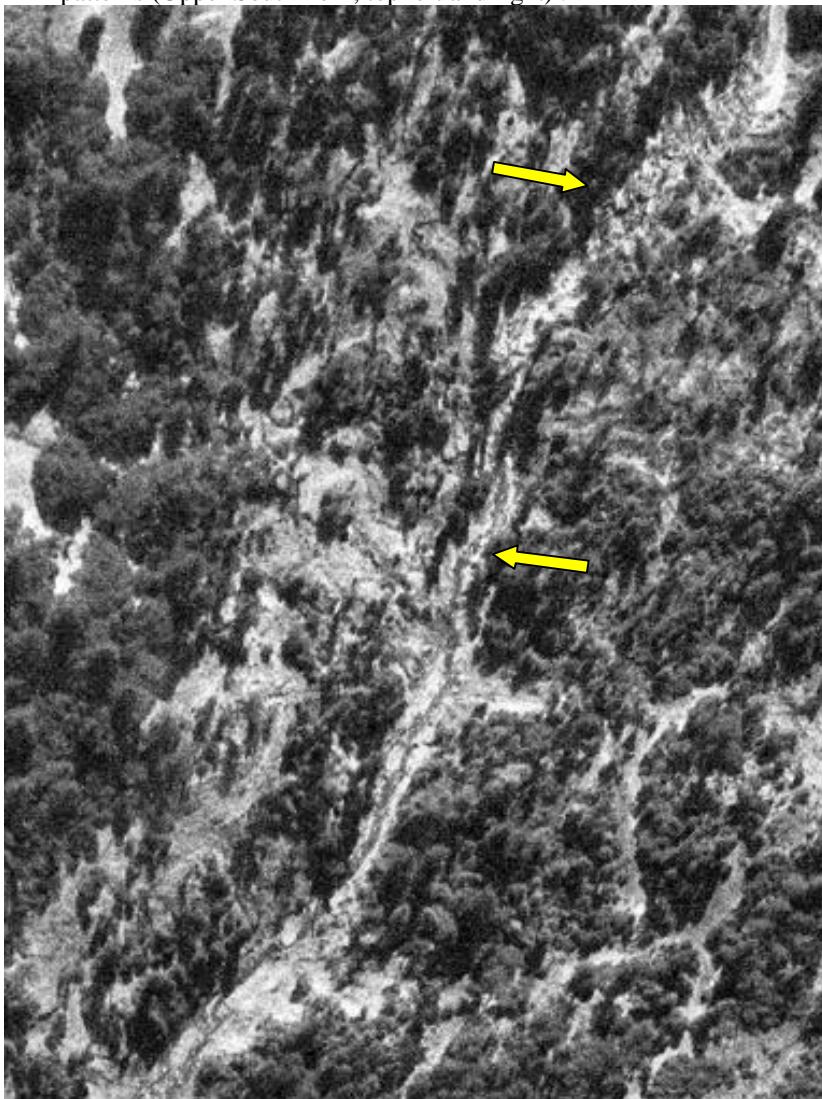
Figure 27: Disrupted channel patterns from in stream tractor operations, House Creek.
