LAND USE HISTORY OF THE GUALALA WATERSHED

BY
DONALD MORSE RPF 2158
CALIFORNIA DEPARTMENT OF FORESTRY AND FIRE PROTECTION

**PREPARED IN COOPERATION WITH THE CALIFORNIA RESOURCES AGENCY'S
NORTH COAST WATERSHED ASSESSMENT PROGRAM**

APPENDIX 3: LAND USE HISTORY OF THE GUALALA WATERSHED

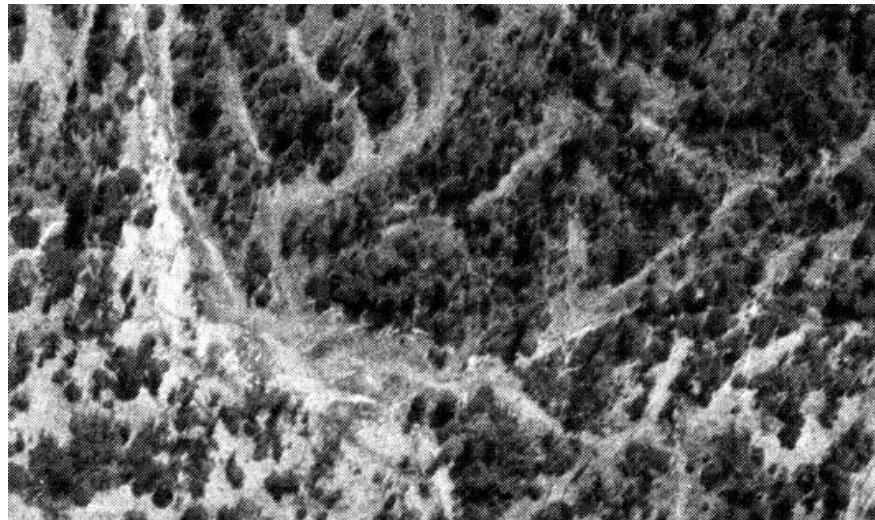
Tributary to House Creek

Figure 28: Top: A large in stream landing complex offset from a braided channel pattern in a tributary to the Upper South Fork.

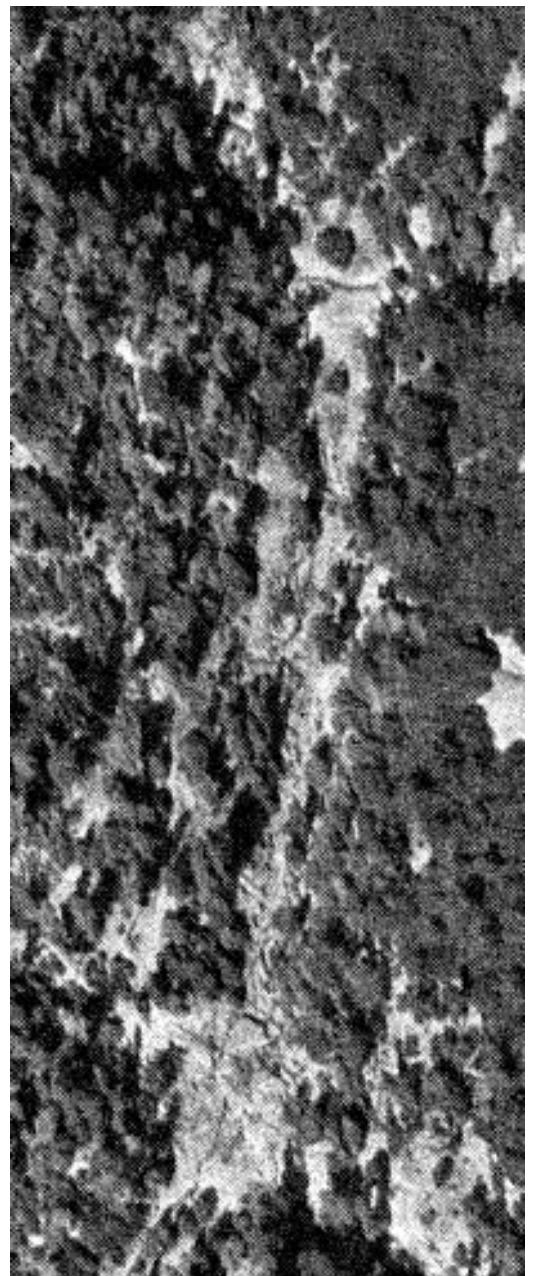
Figure 30: Tractor yarding throughout the stream leaves a disrupted channel with angular and diffused channel patterns post operations (top and bottom right).

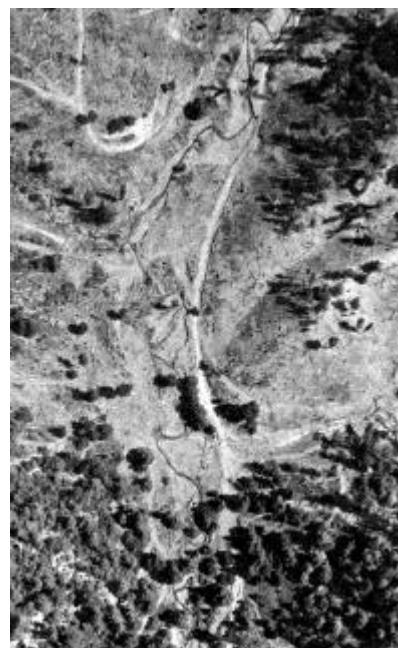
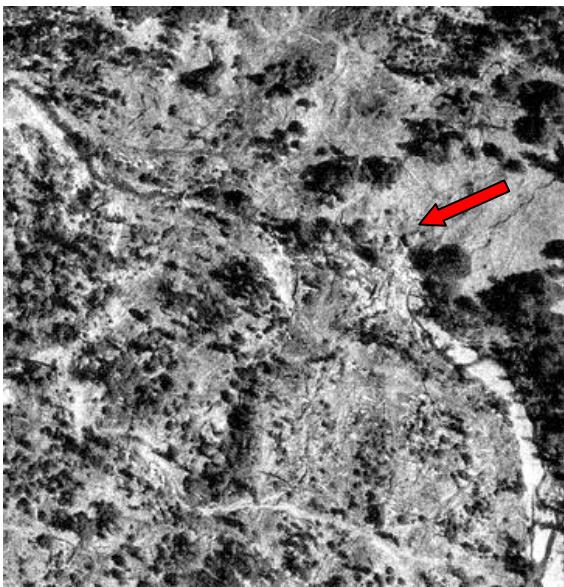
Figure 31: Left: Mid century logging operations frequently used primitive stream crossing structures. Log chunks were pushed into the stream channel and topped with dirt fill. Large storm events (1964 storms in this case) often overflowed onto to these crossings, creating a disrupted meandering channel pattern through these structures (red arrow). Right: Riparian stream clearance and streamside road networks in a tributary to Marshall Creek.

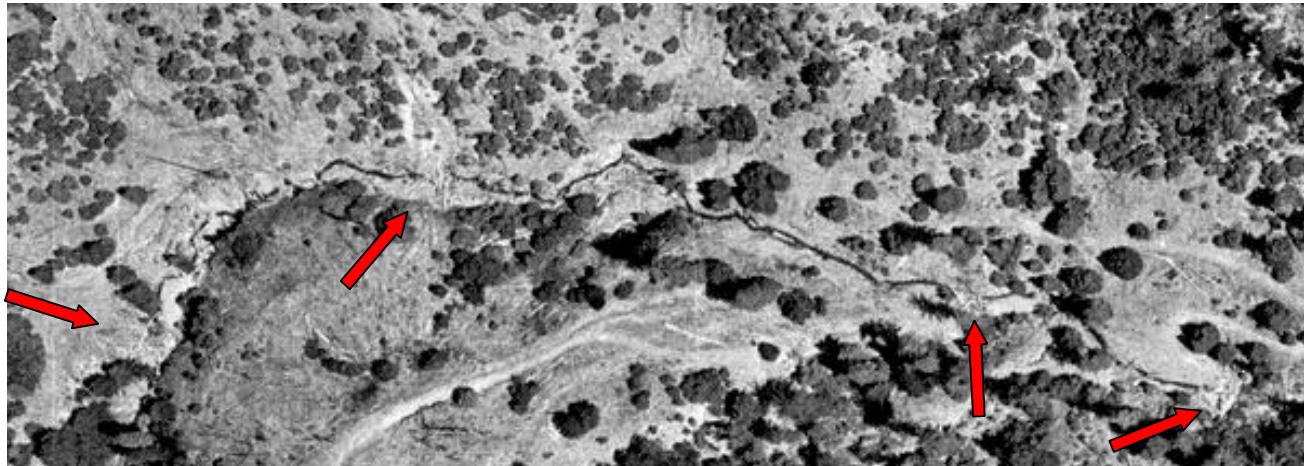
Figure 32: Riparian stream clearance removed coniferous cover in a lower tributary stream to House Creek. These stream crossings (red arrows) also used log chunks pushed into the channel and were topped with dirt fill. The meandering stream channel patterns at the crossings shows the depth of these structures where the stream makes abrupt switchback turns.

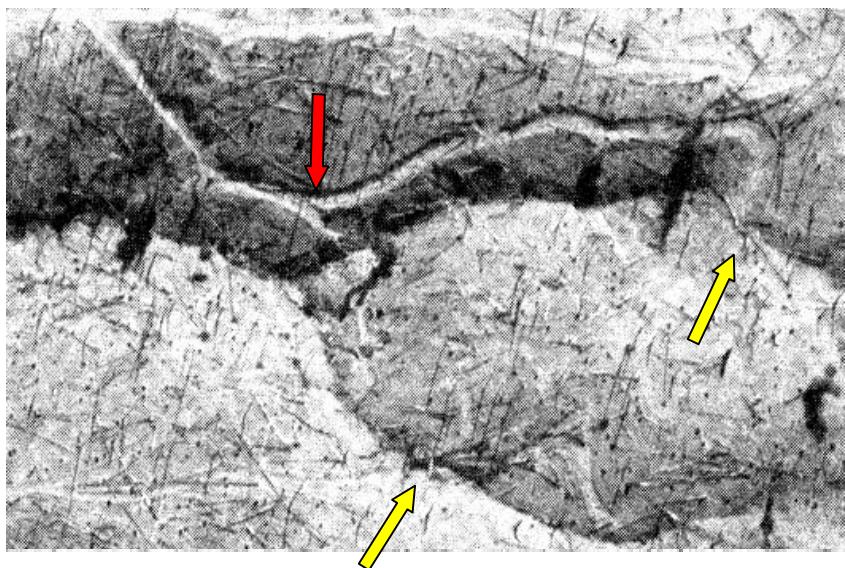
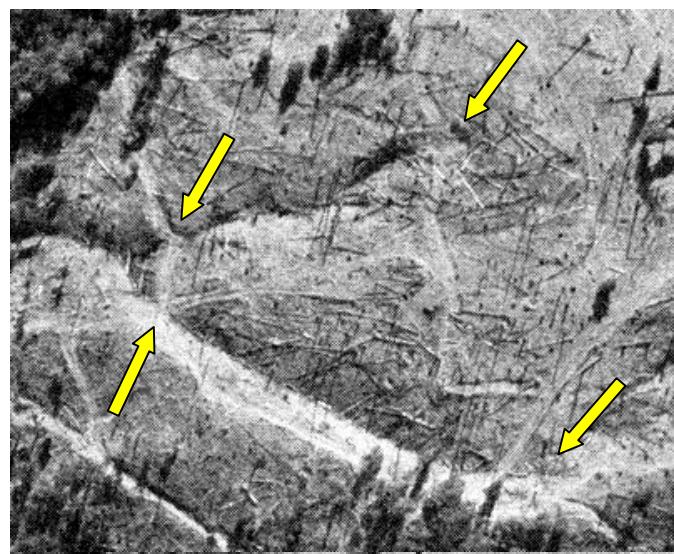
Figure 34: Reentry of the mid century tractor areas under a Timber Harvest Plan typically requires the repair of legacy impacts that continue to represent present day sediment sources. In this case above, the THP could require installation of cross ditches along the abandoned seasonal roads. This would disperse runoff away from the low point in the road and resulting debris slide covering the creek where flows had concentrated. (red arrow). Timber Harvest Plans frequently require removal and stabilization of failing stream crossings left abandoned (yellow arrows). Typical procedures include (1) removing of the decaying log chunks and soil debris from the channel crossing point, (2) grading back the road approaches and (3) applying grass seed and mulch to the exposed ground. Similar repairs have been effected throughout the watershed where covered under a Timber Harvest Plan, substantially reducing sediment point sources and contributing to improving channel sediment conditions noted in the CGS geofluvial analysis.

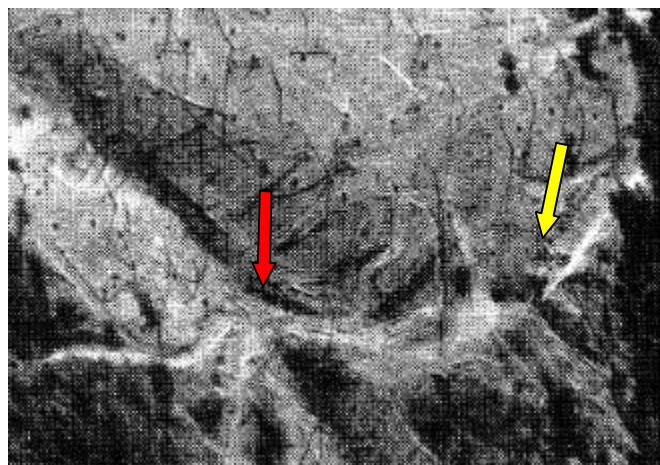
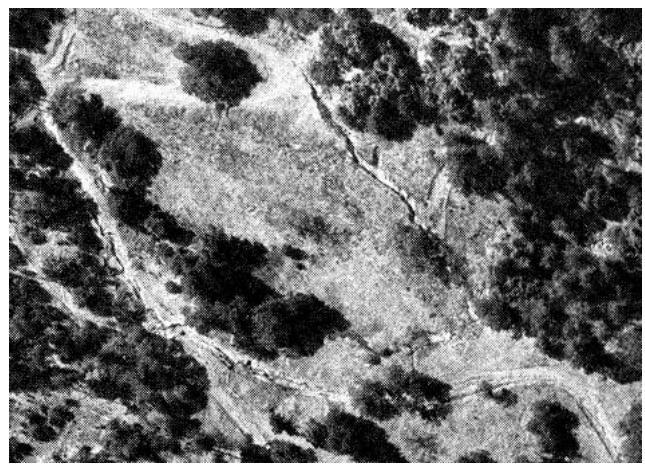
Figure 35: Left: In higher tributary watercourses that exhibited low flows in the summer, tractors pushed dirt straight into the stream to make the road crossing. The red arrow shows where a switchback turn in the road was made in the center of the creek. The yellow arrow shows where the fill slope failed as a debris slide at a second dirt fill road crossing of a stream. If such an area were subject to a THP, culverts sized to a 100 year storm event would be required today. Or the stream crossings must be pulled back and stabilized with grass seed and mulch prior to the winter rains. Right: Repair of gully erosion down abandoned roads dating to the mid century is typically repaired in areas subject to THPs. This includes installation of cross ditches, upgrading culverts and regrading inside ditches.

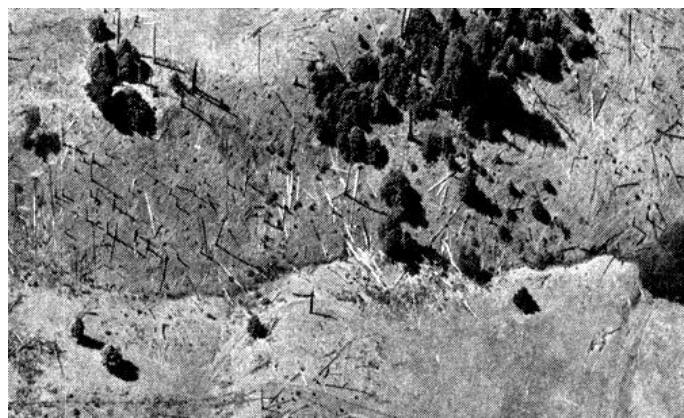
Figure 36: The Gualala NCWAP Team frequently recommended tree planting of former riparian areas that had been converted to pastureland during the mid century. The 1965 photo (left) of a tributary to the lower reaches of House Creek shows conifer extraction from the stream leaving oak and madrone upslope, surrounded by existing grasslands. Such procedures were common in the east and upslope basin reaches. Artificial regeneration can be difficult. These areas are often highly compacted from decades of prolonged cattle grazing. Several planting seasons are usually required to overcome high seedling mortality rates.

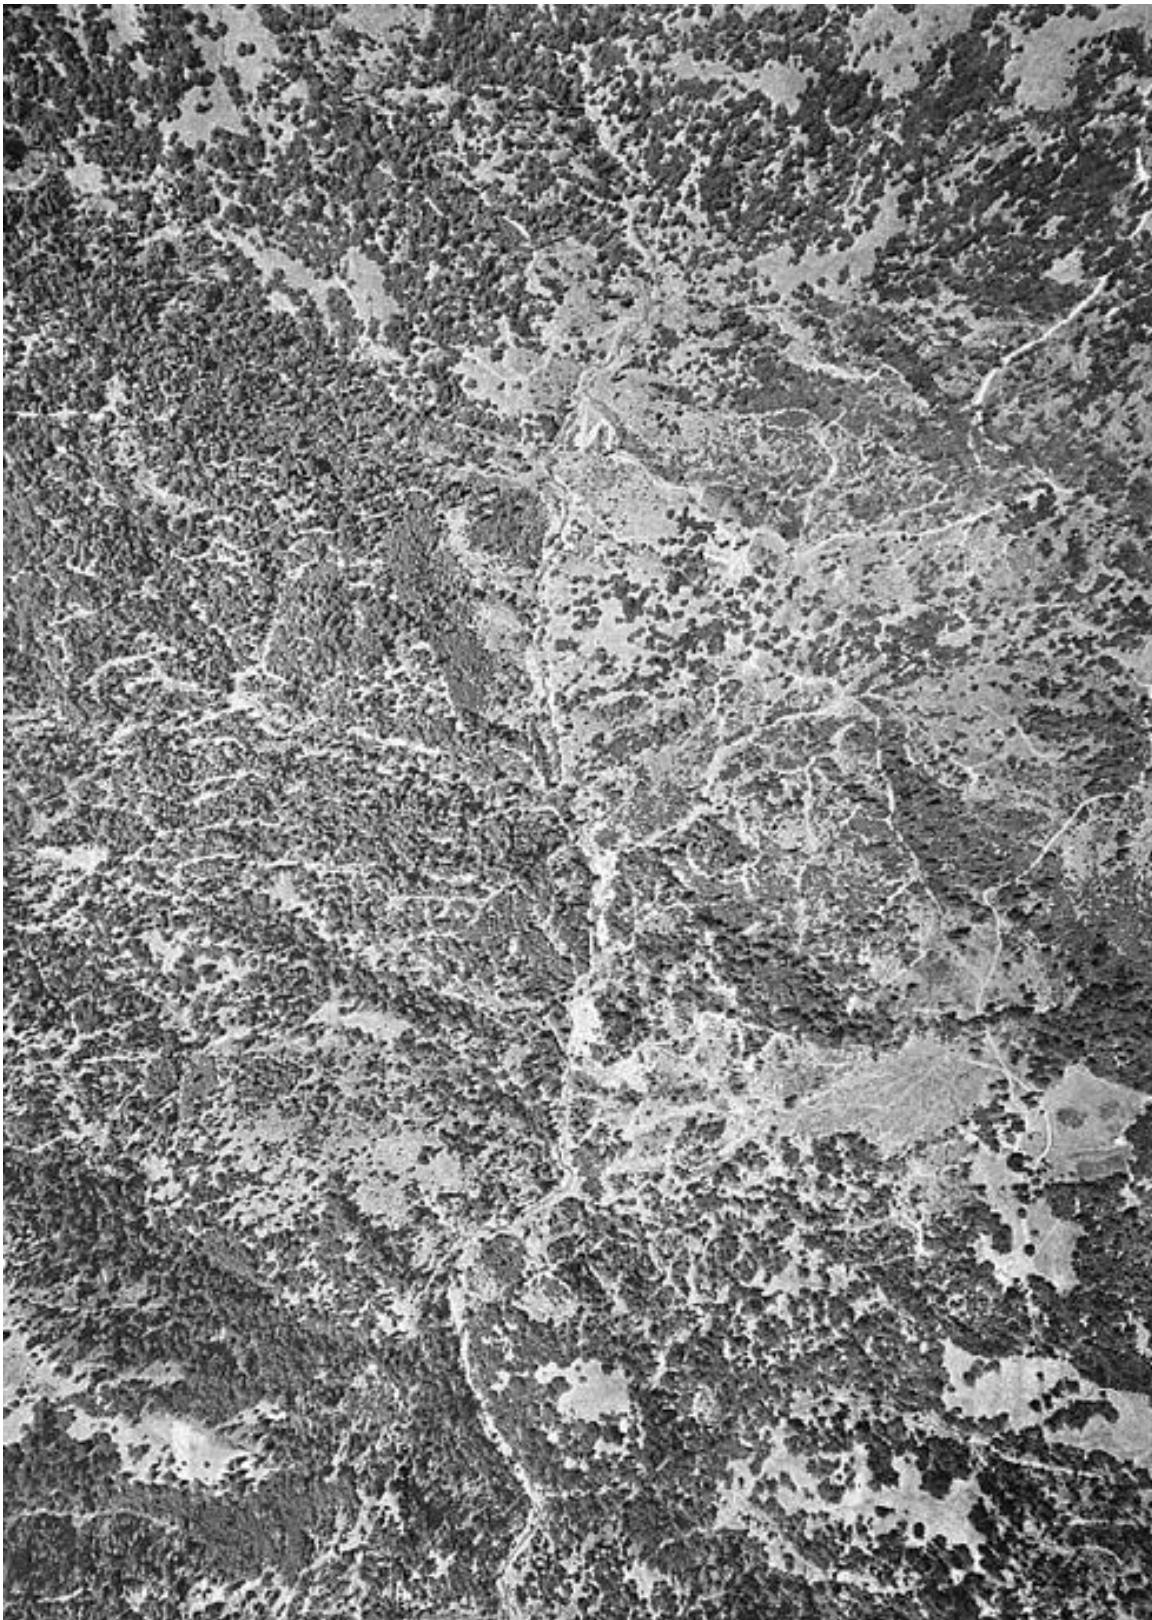
Figure 37: Long term residual effects of streamside/ in stream road construction, June, 1965. A tributary to the Upper South Fork was logged in the mid 1950s. This 1965 photo shows vegetation returning on the clear cuts indicating approximately 7 to 10 winter storm runoff periods on these roads. The in-stream road network (center) incised deeper over time, trenching down the road. There had been large storm events in 1962 and 1964 affecting this area. Numerous debris slides and debris torrent slides have been found in this photo.

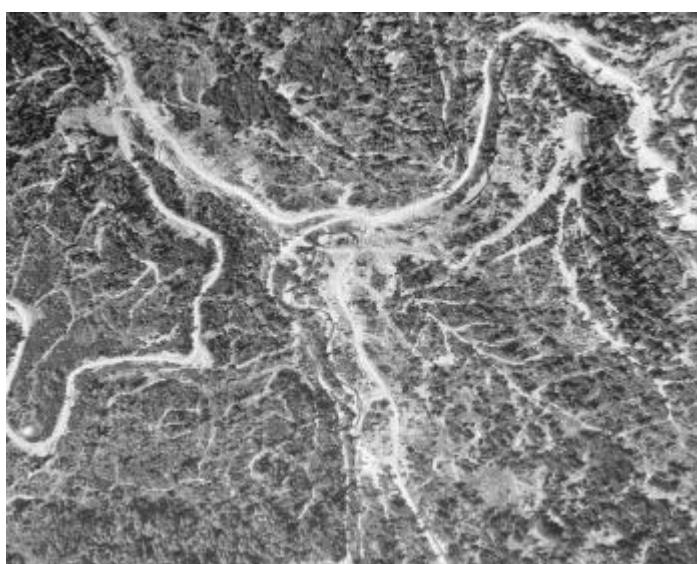
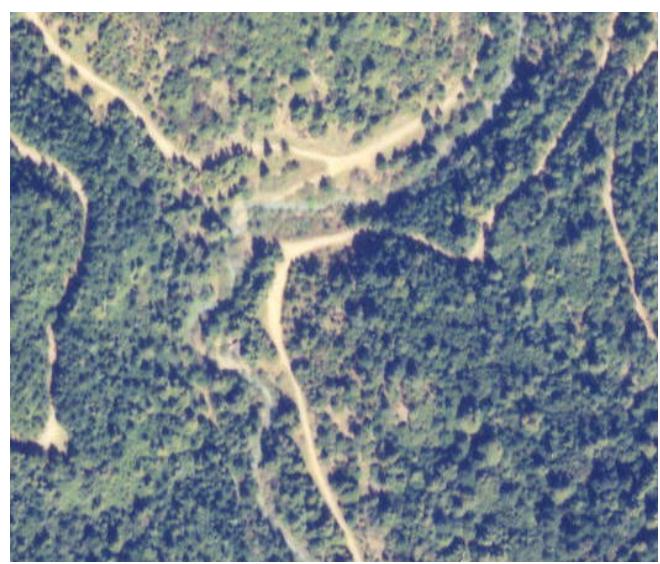
Figure 38: Fuller Creek landing complex, June, 1965 (left), and 1999 (right). Fuller Creek meanders around debris depositions in 1965 in contrast to a more lineal pattern today.

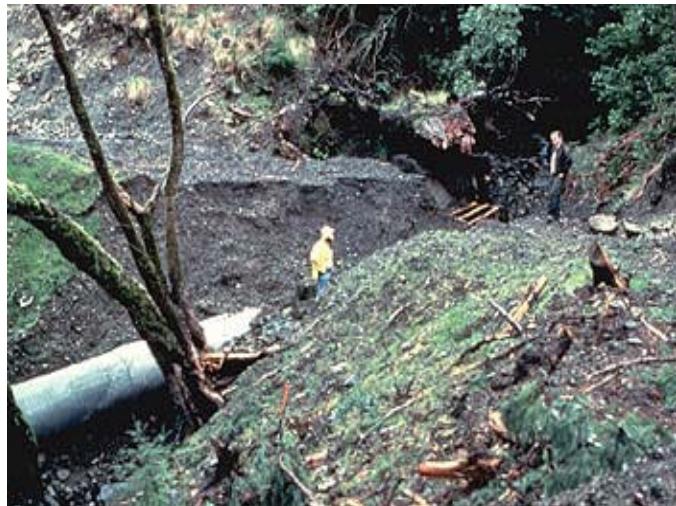
Figure 40: Culvert failure of contemporary road networks

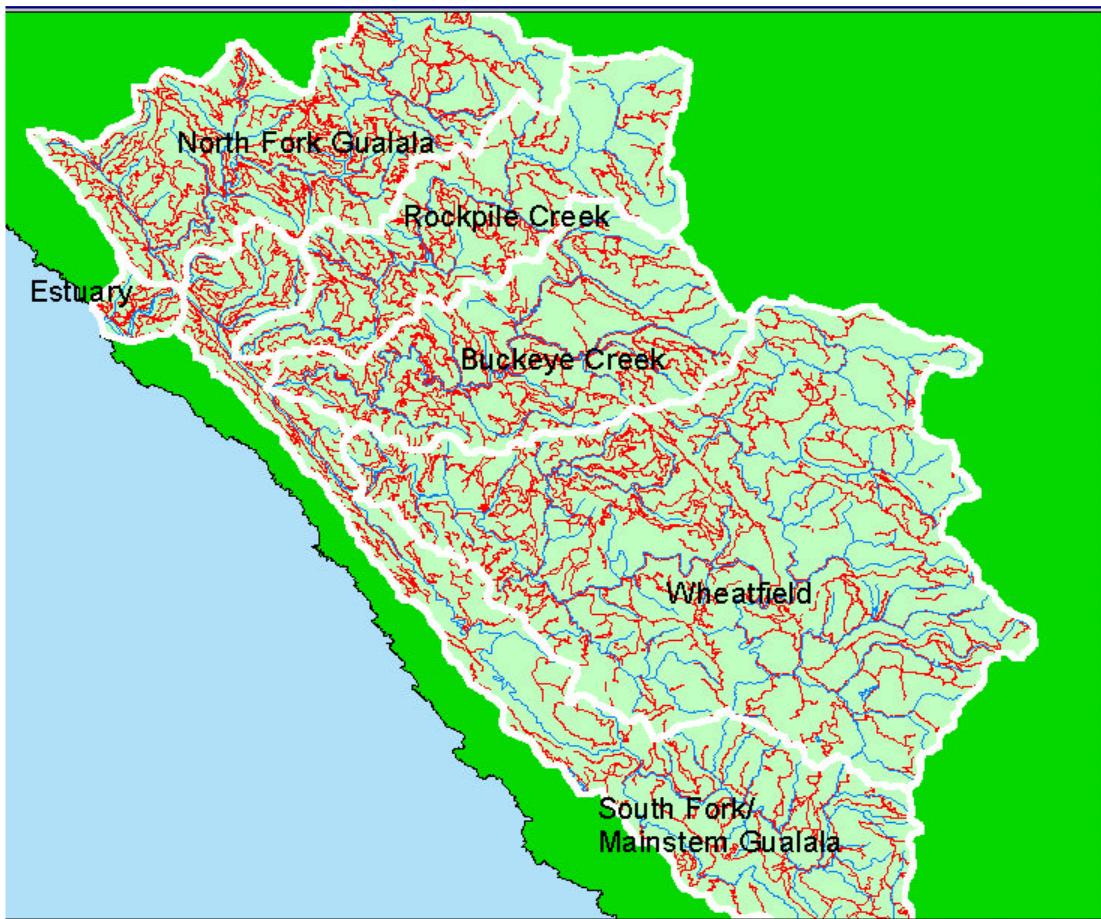
Figure 41: Current permanent and seasonal road network of the Gualala Watershed

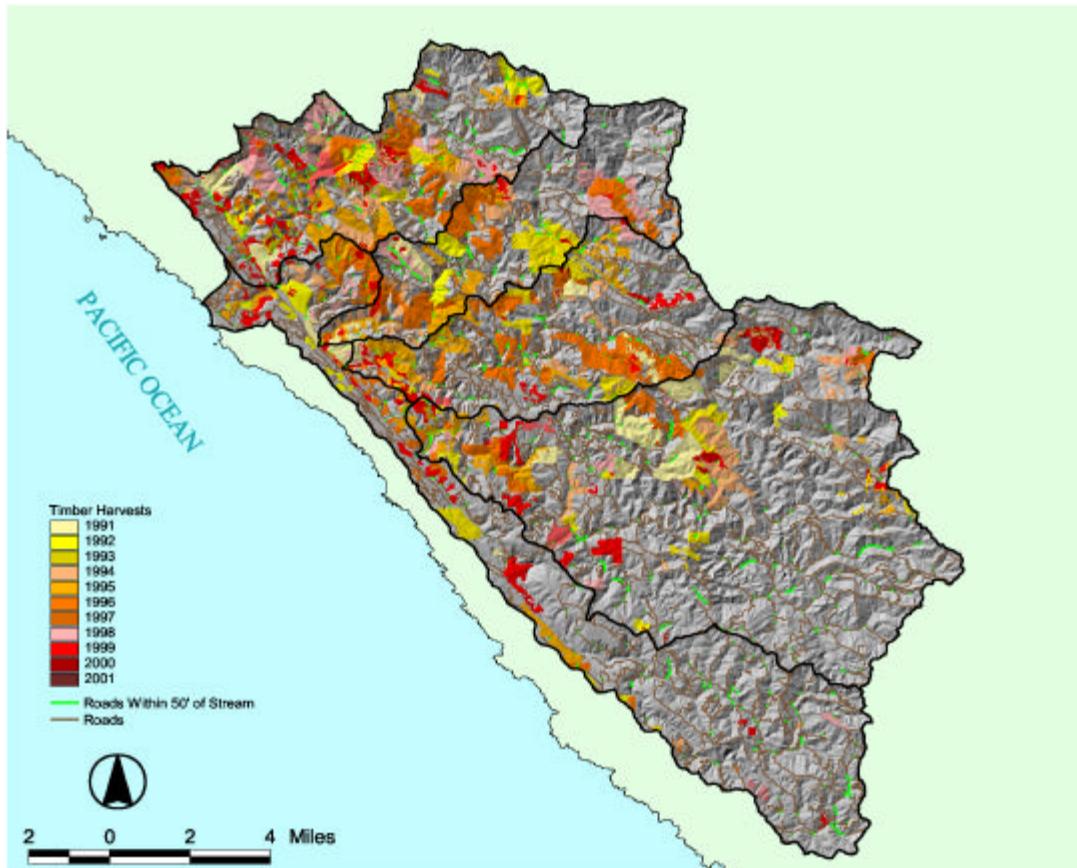
Figure 42: ICE roads located within 50 ft. of a watercourse (green), with 1991 to 2001 THPs.

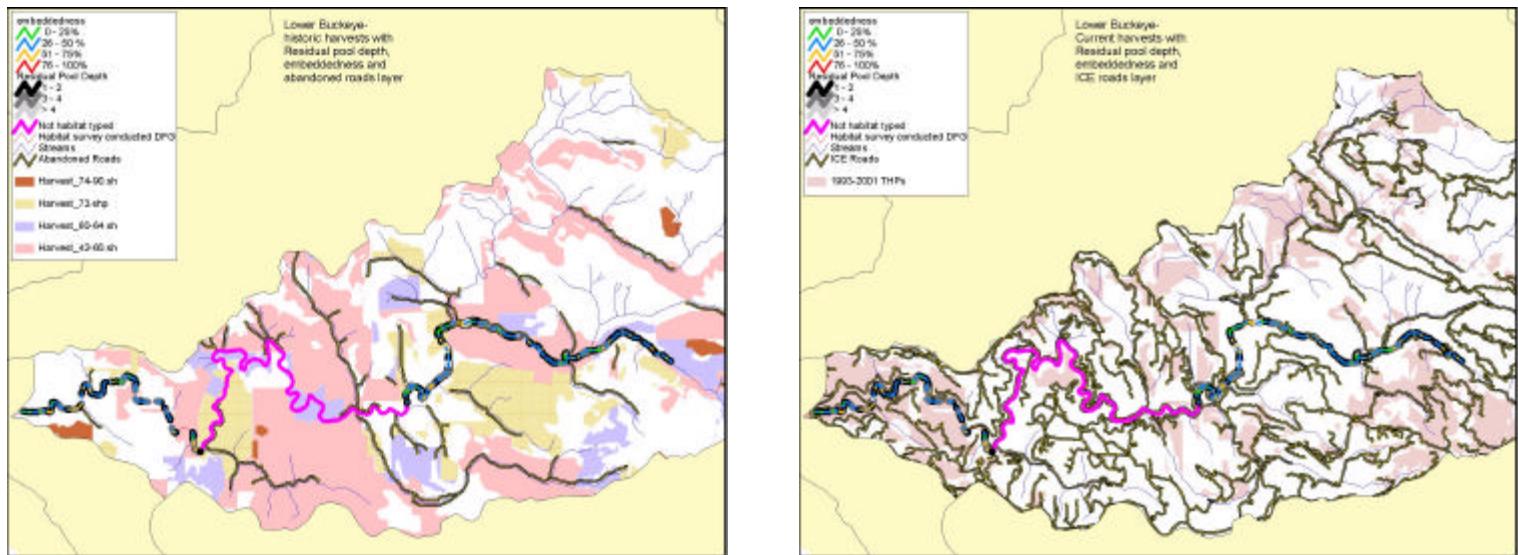
Figure 43: Buckeye streamside roads with pre 1973 stand replacement areas left), and the modern road network (right) with 1991 to 2001 THPs.

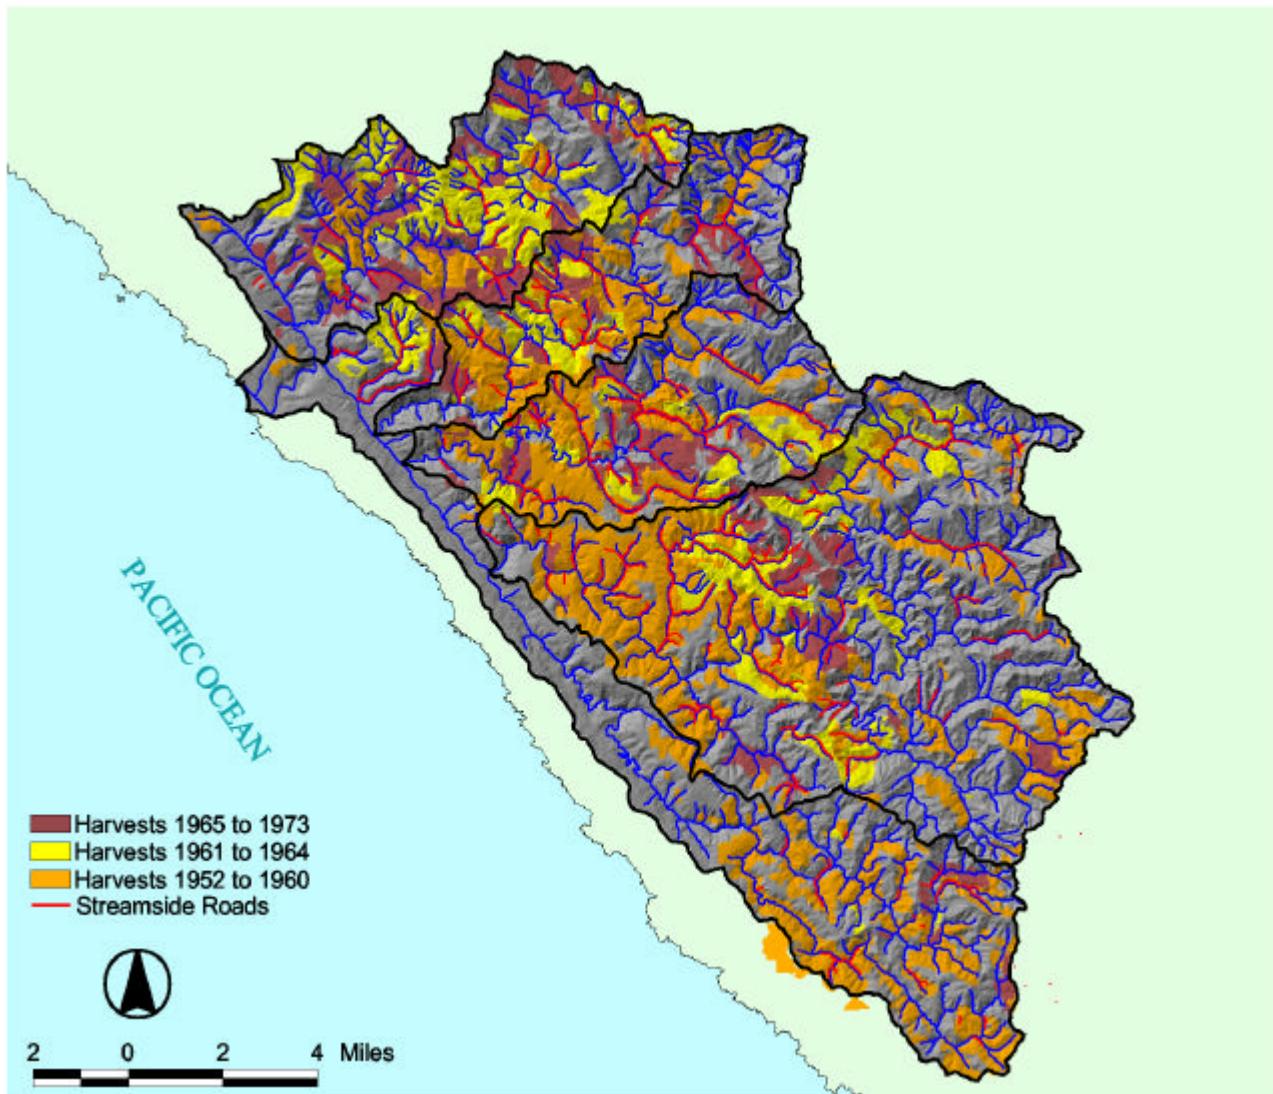
Figure 44: Mid century streamside/ instream roads and landings. Pre-1973 harvests are shown in three separate time strata.

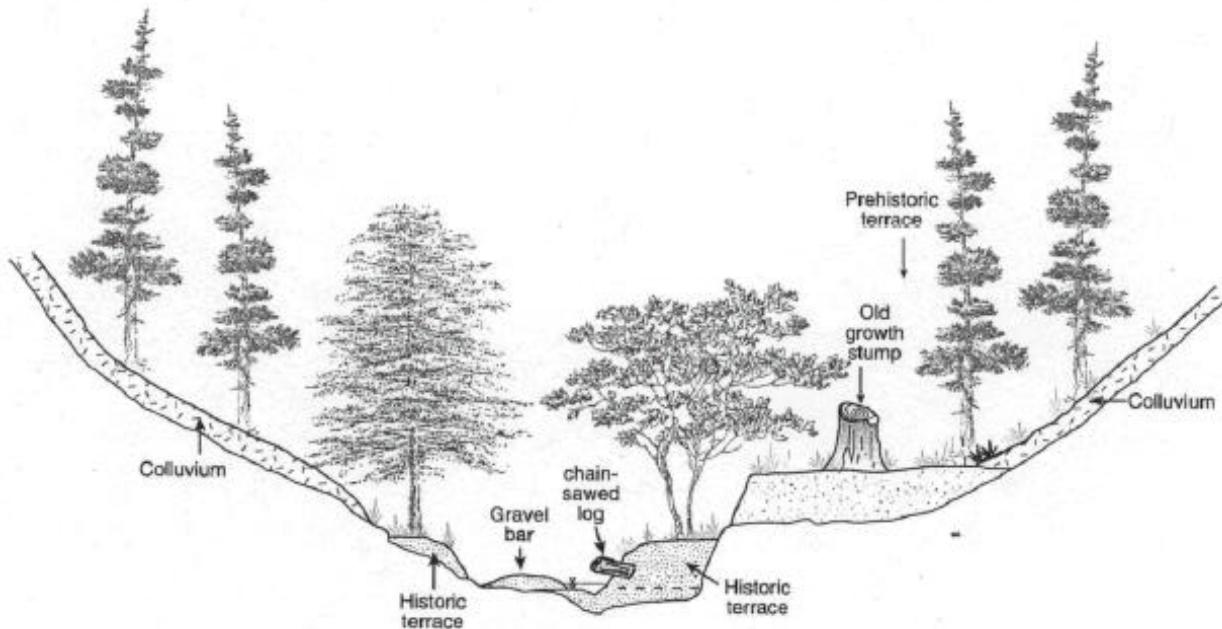
Figure 45: Schematic sketch of a typical South Fork Noyo River channel showing valley margin, prehistoric terrace, historic terraces, gravel bar, and channel. Historic terrace deposits are observed on bedrock in some locations (left) and on channel deposits in other locations (right). Old growth redwood stumps are diagnostic of prehistoric deposits and embedded chain-sawed logs are diagnostic of historic deposits. Prehistoric terraces support second growth redwood trees and ferns, historic terraces typically support alder trees and grasses.

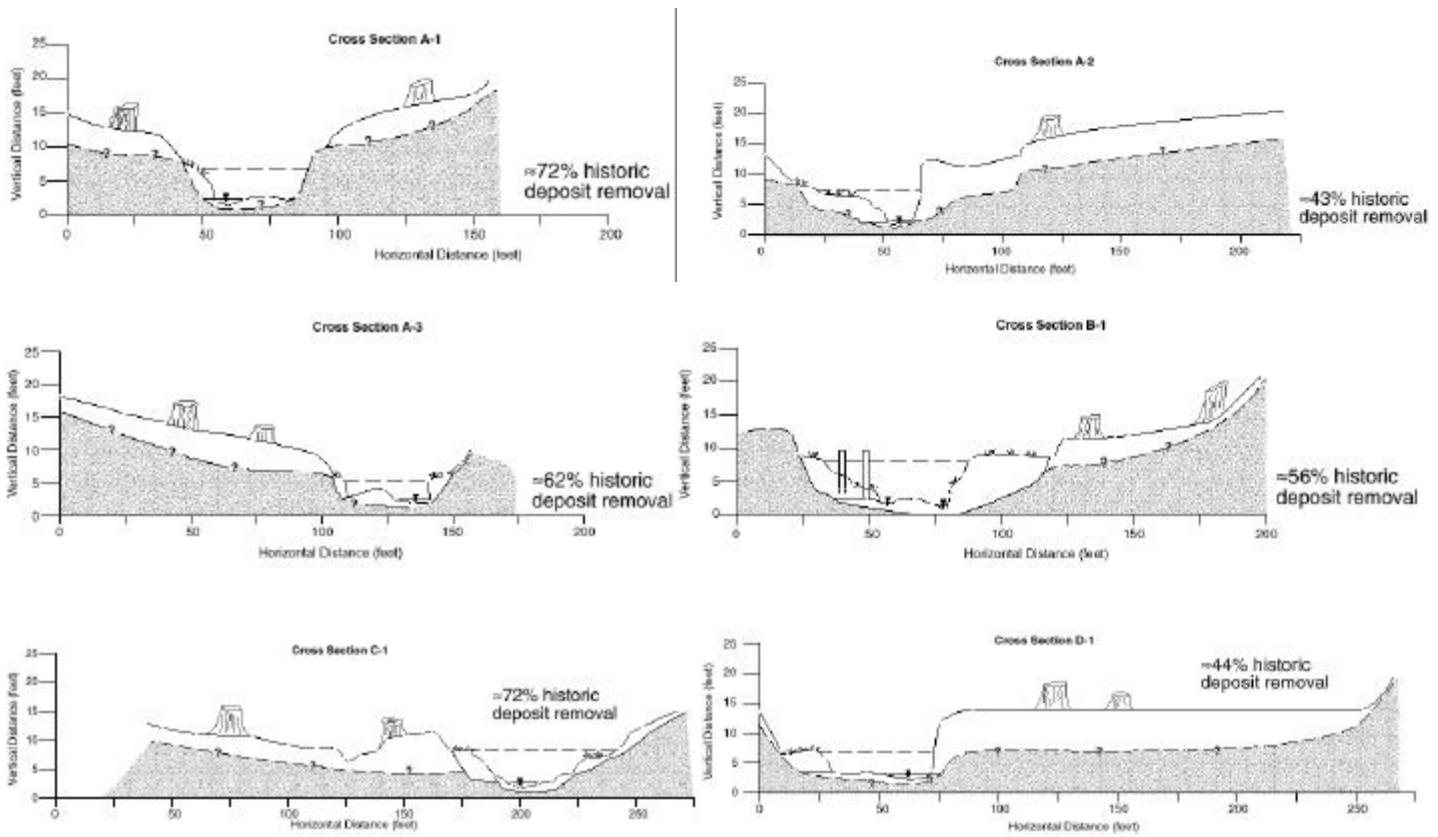
Figure 46: Six survey cross sections. Dashed lines represent probable maximum thickness of historic aggradation used to estimate amount of material removed since time of terrace deposition.

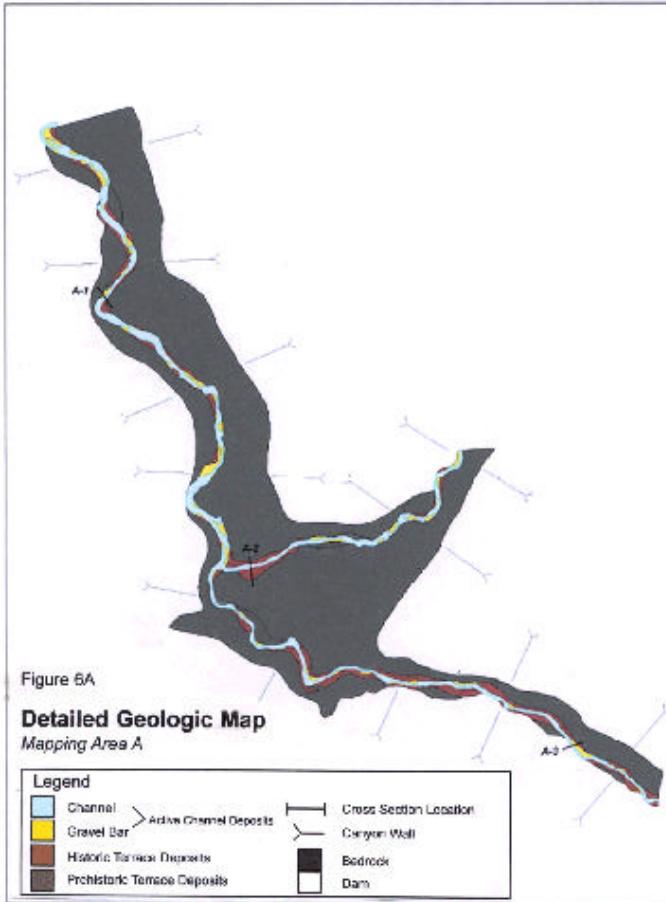
Figure 48: Additional stream channel maps showing active channel deposits, historic and pre-historic deposits, and bedrock in the South Fork Noyo Watershed. Brown = historic terrace, Grey = geologic, or pre-historic terrace, Yellow = gravel bar.

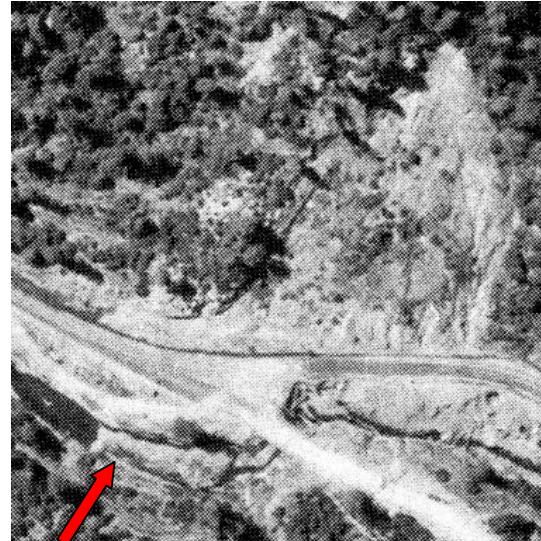
Figure 54: Left: Streamside road network leads to a landing complex adjacent to the North Fork Wheatfield. This streamside landing was built onto a natural geologic sediment terrace, as verified in 1942 photos.

Right: Kelly road built through an active slide area, 1965. The left bridge approach was built onto the slide mass that had slumped into Buckeye Creek. The 1964 flows undermined the left bridge approach, causing the edge of the road to collapse (red arrow). Note braided channel pattern patterns indicating an aggraded stream channel. 1999 photos show this same area with fewer braided channel patterns indicating decreasing bed loads. Also note log debris that had floated down onto the bridge approach.

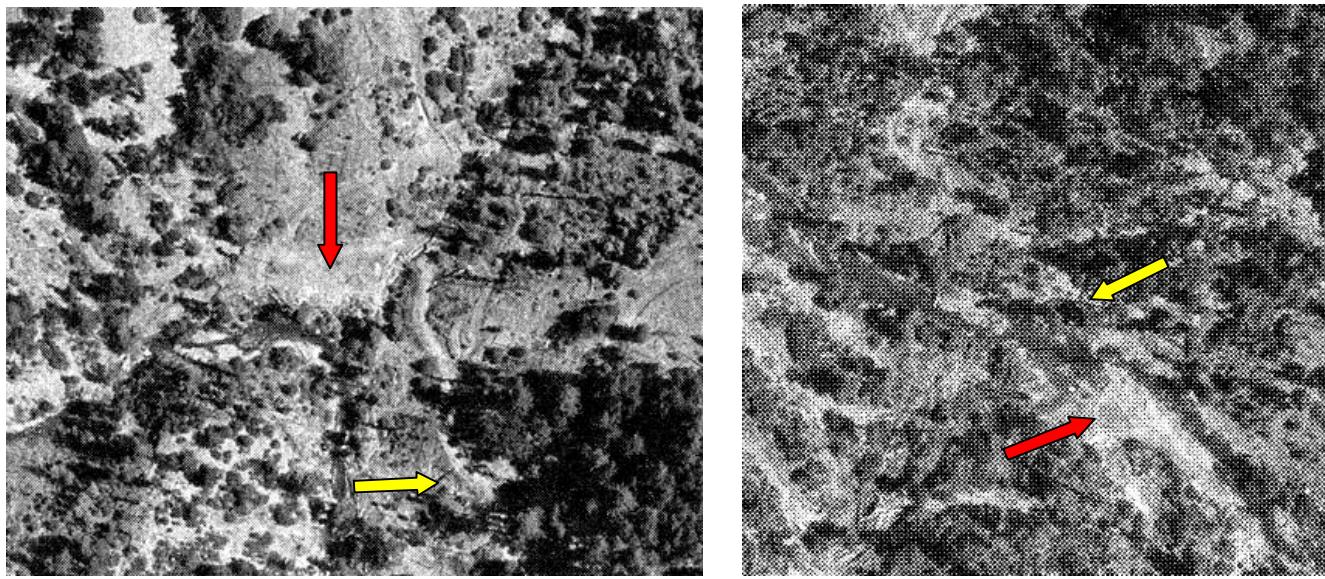
Figure 56: Left: In stream landing operations (red arrow) adjacent to an old growth residual stand (yellow arrow) showing original conifer tree cover over an upper tributary stream to Marshall Creek.

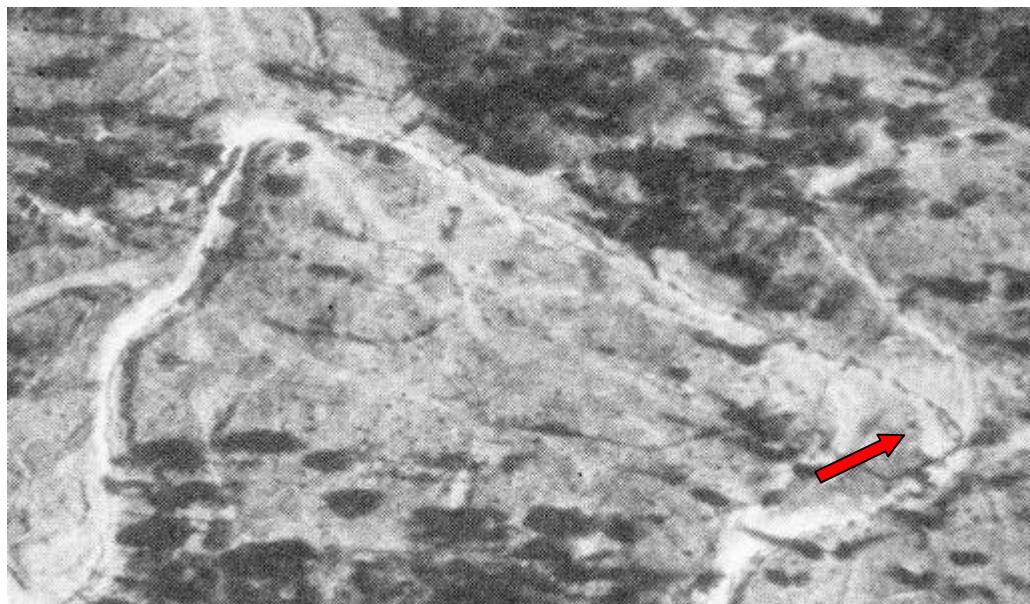
Figure 57: Stream diversion (red arrow) of a tributary stream to the North Fork Wheatfield onto a logging road

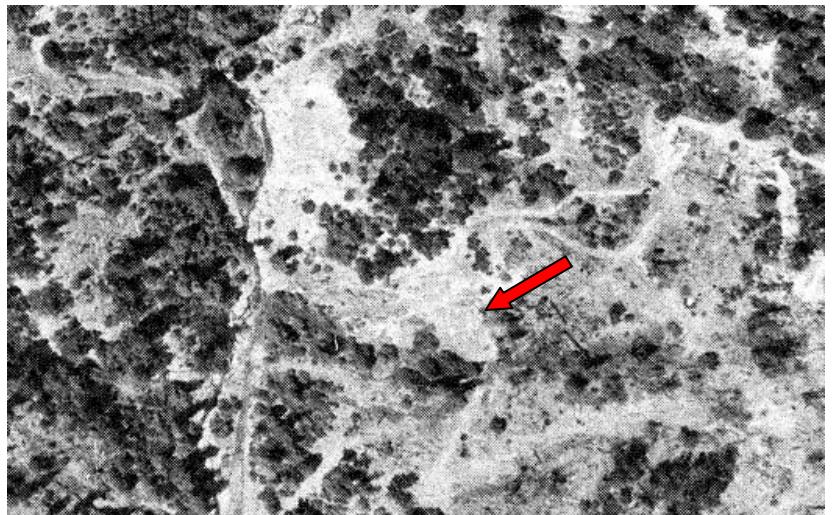
Figure 60: Left: In stream landing. Right: A large debris slide removed a portion of the logging road.

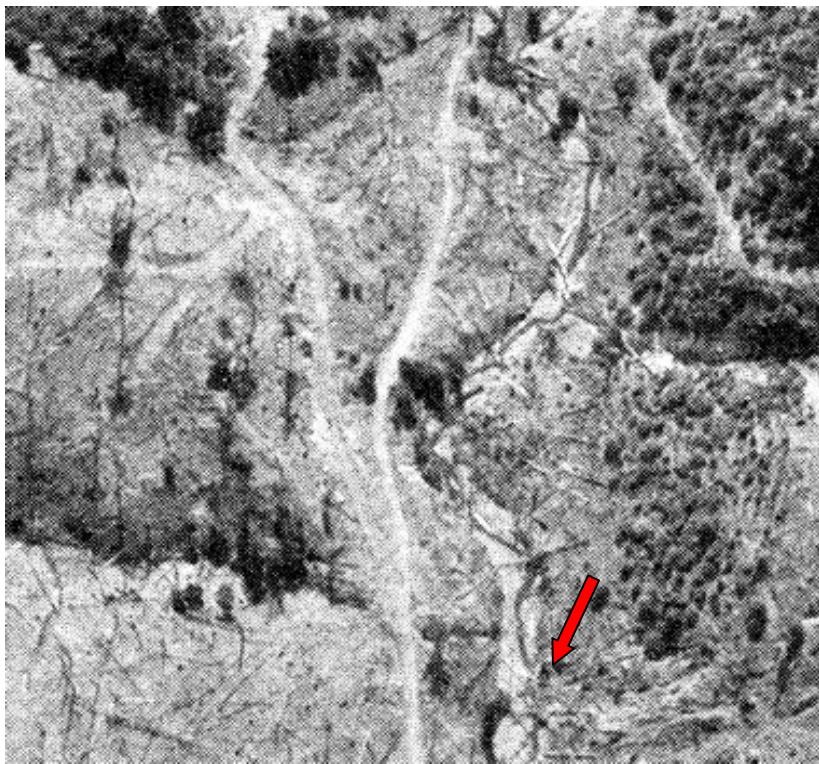
Figure 62 : Top: Road building along the streambed graded the channel smooth and straight creating a ditch. Left: Riparian clearance and logging debris over a tributary to Danfield Creek. Note debris accumulations over channel at a skid crossing (red arrow).

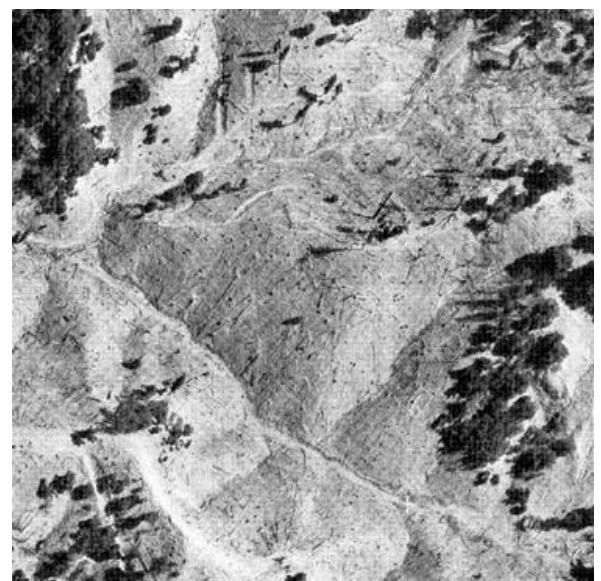
Figure 63: Left: Riparian clearance over a tributary to Danfield Creek. Note skid crossings incised down by the main channel (red arrow). The streams were not used as skid trails in this area. Right: Riparian conifer removal along an unnamed tributary to the Main Stem Wheatfield Fork downstream of the confluence with House Creek.

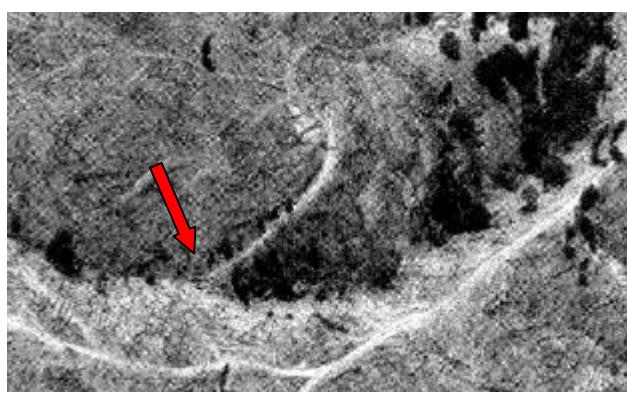
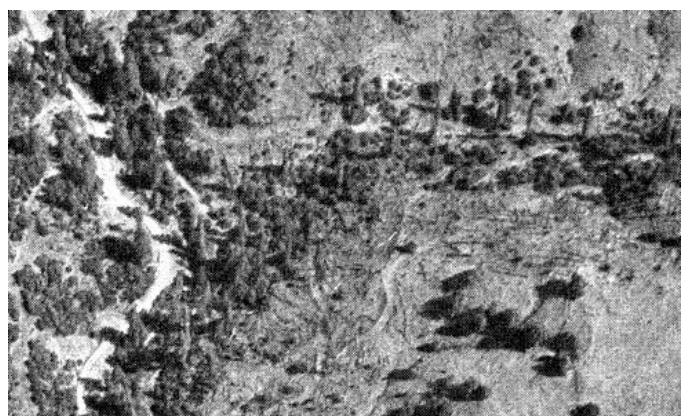
Figure 64: Potential THP repair site of a legacy stream crossing. Right: Concurrent logging operations in Pepperwood Ck.

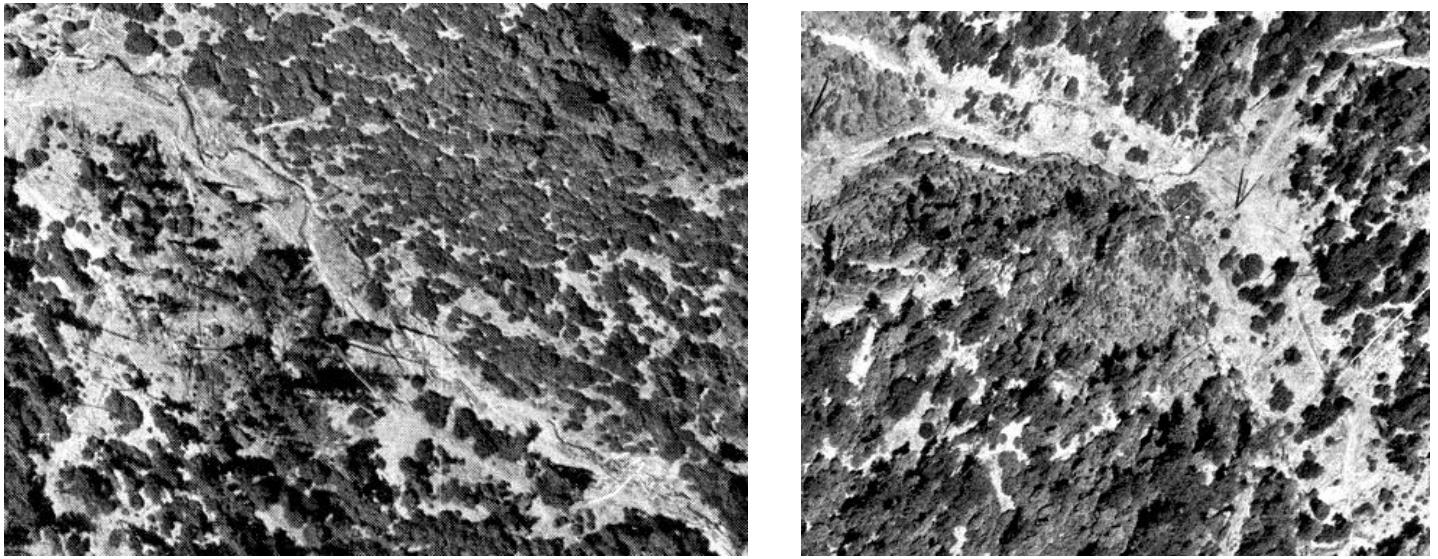
Figure 65: Streamside roads often made several crossings over channel to avoid ungradable obstacles along the streambed in a lower tributary stream to House Creek.

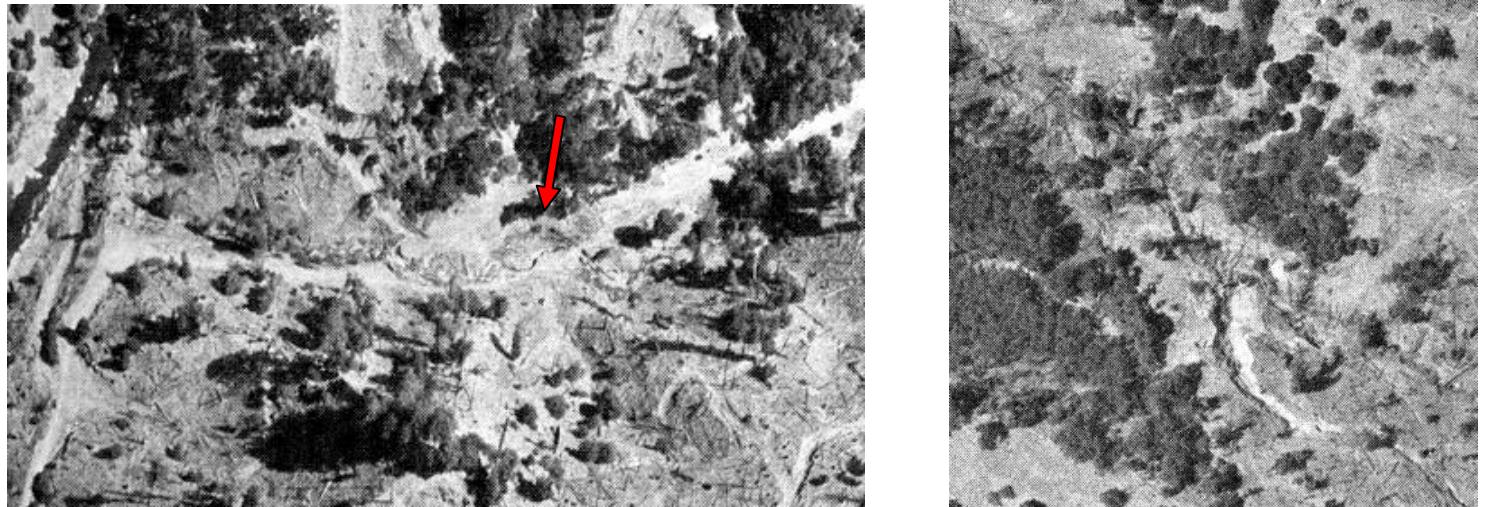
Figure 66: Wheatfield Fork (upper left) downstream of the confluence with House Creek. Red arrow shows a washout of a portion of the streamside road. Right: Debris torrent slide in the Danfield Creek tributary subbasin within a logging area in 1965.

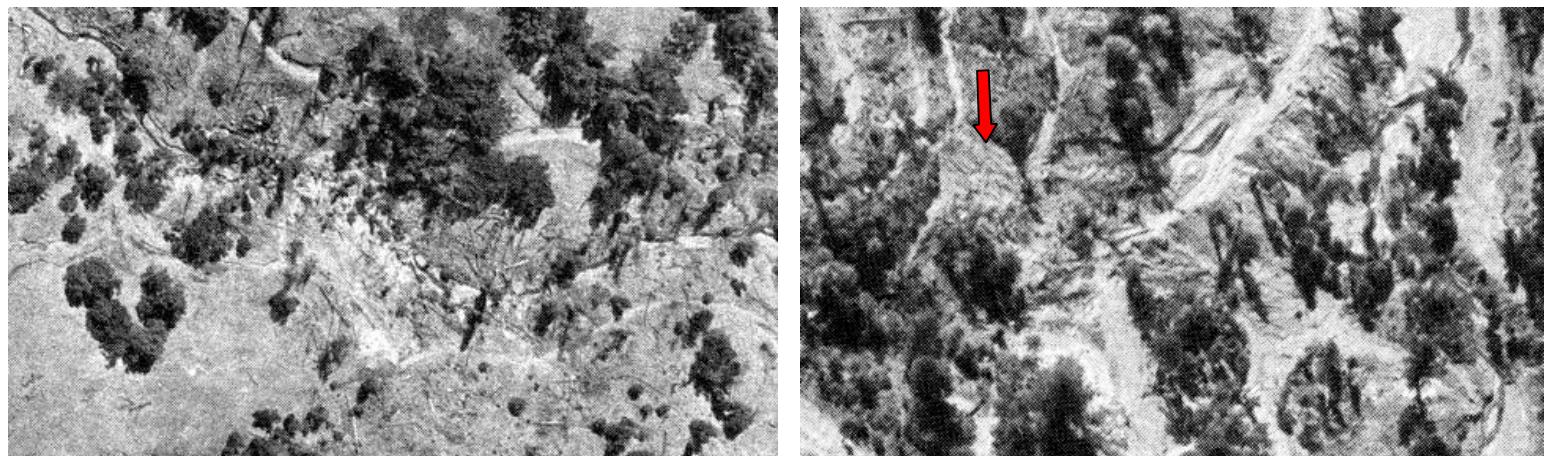
Figure 67: Left: Angular channel pattern at a stream crossing. Right: A debris slide breaching three road contours at Wolfe Creek (right).
