LAND USE HISTORY OF THE GUALALA WATERSHED

BY
DONALD MORSE RPF 2158
CALIFORNIA DEPARTMENT OF FORESTRY AND FIRE PROTECTION

**PREPARED IN COOPERATION WITH THE CALIFORNIA RESOURCES AGENCY'S
NORTH COAST WATERSHED ASSESSMENT PROGRAM**

APPENDIX 3: LAND USE HISTORY OF THE GUALALA WATERSHED

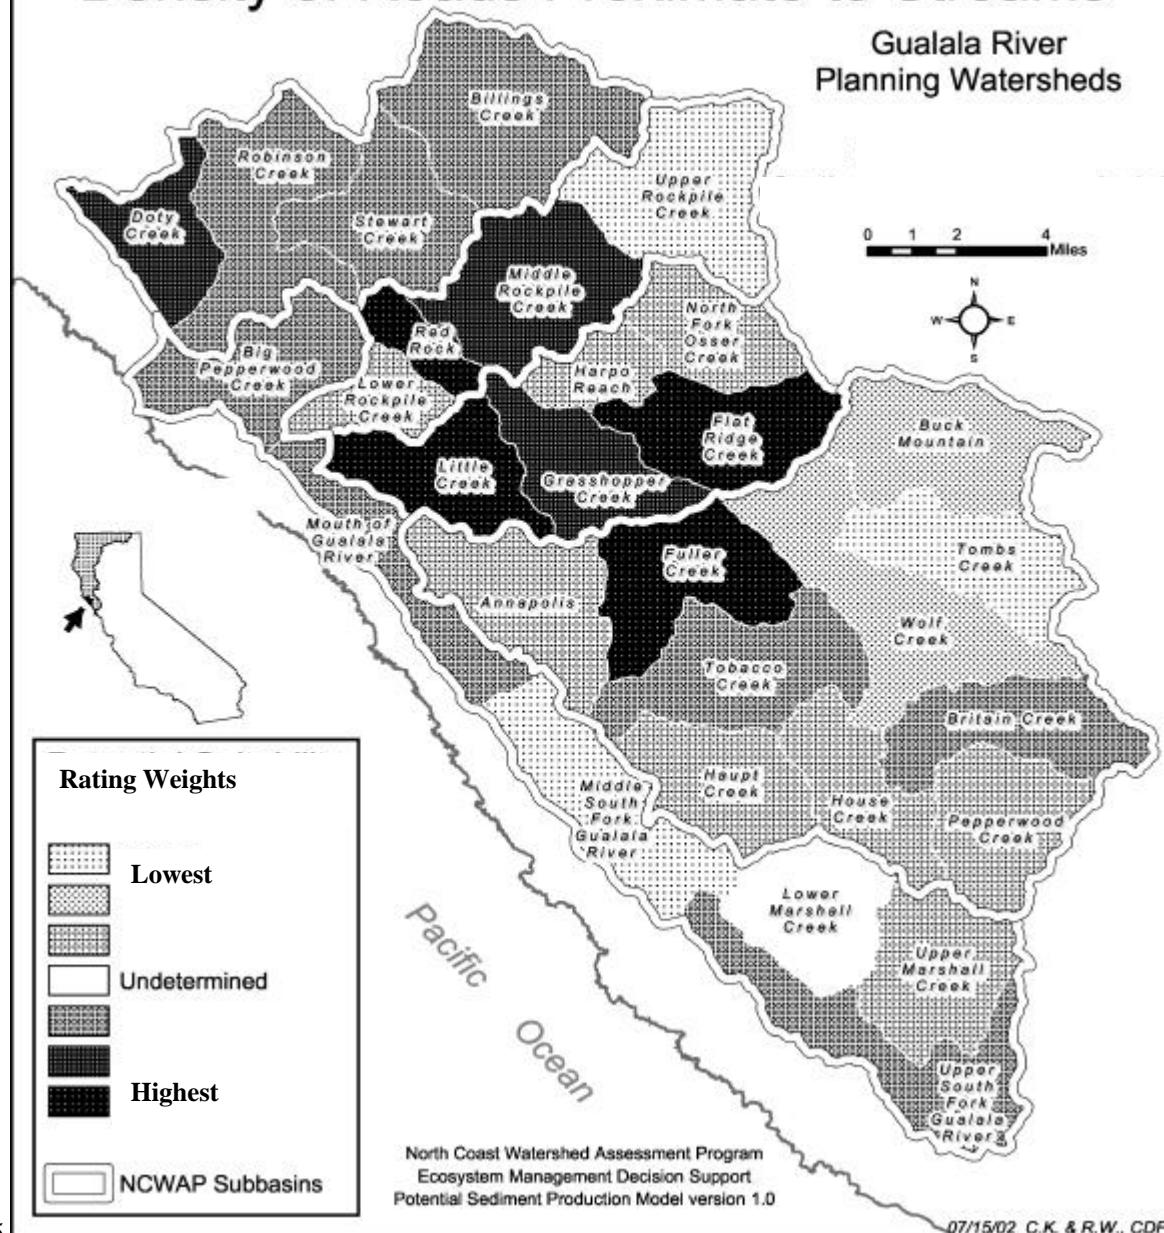
Appendix A: Density of Roads Proximate to Streams shows total length of roads near watercourses. Planning watersheds with a high density of roads near streams show where additional field scrutiny is advised to determine the necessity of road upgrade and improvement work. Planning watersheds in lighter tones show lower priority areas based on this assessment.

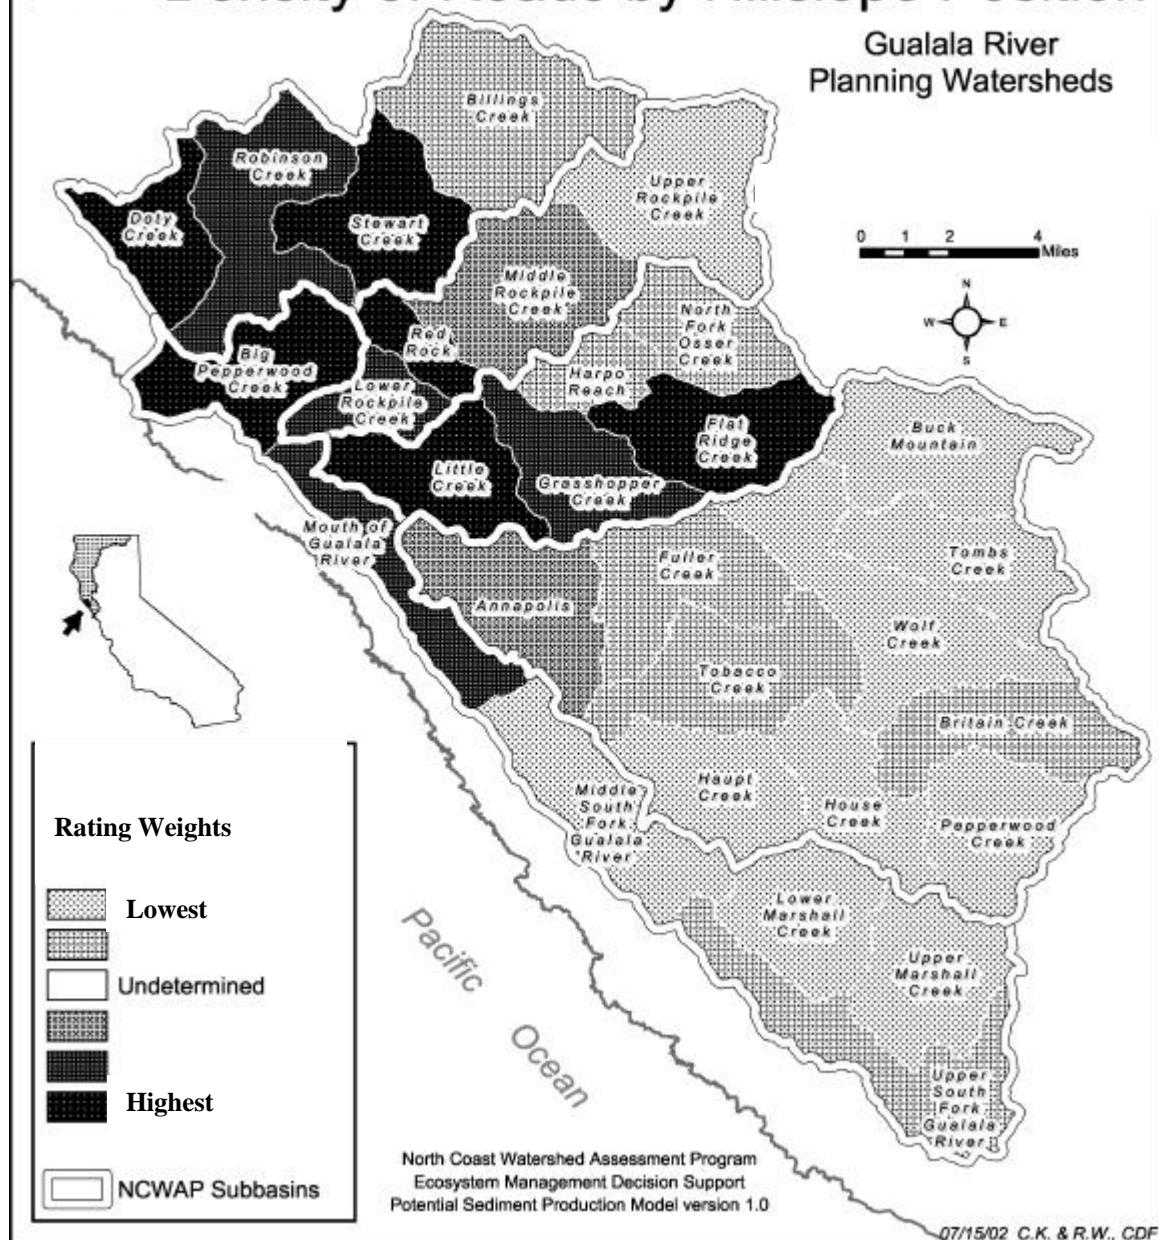
Appendix B: Density of Roads by Hillslope Position shows length of road, weighted by position on the sideslope.. The tones in this map are the length of road in each watershed weighted by their position relative to ridges. Roads in the lowest 40% of slope positions are weighted the highest (0.6), while those close to ridgetops are weighted the lowest (0.1). Roads between are weighted 0.3. Planning watersheds in darker tones show comparatively longer lengths of roads on lower portions of the sideslope.

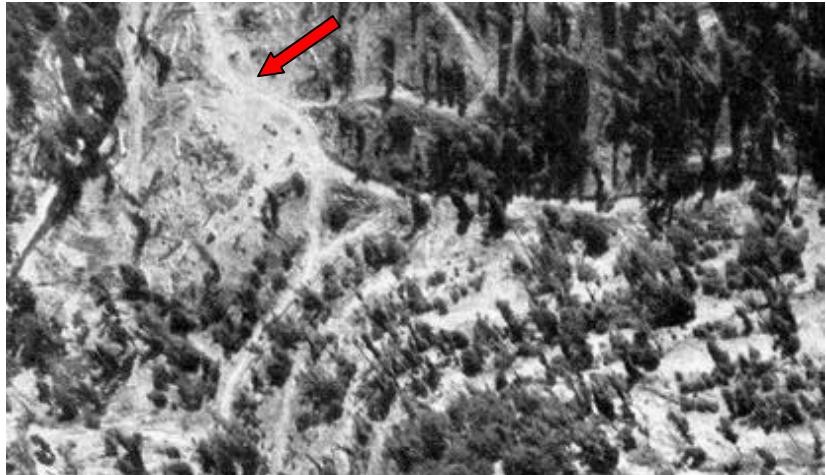
Landing complex built on an alluvial terrace

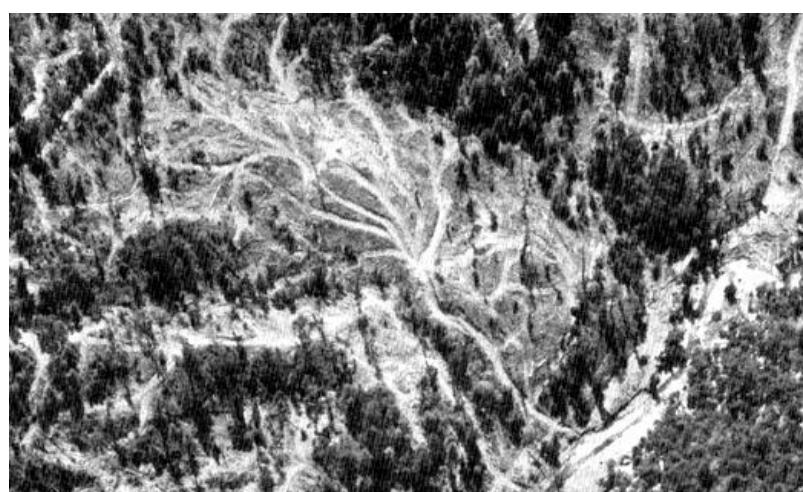
Road network leading downslope to a mainline streamside road along Wolfe Creek
